A “Tearing Down” and the Aspiration to Something Greater: A Freedom Colony Church Falls in Vox Populi, Texas”

*By Michael O’Brien**

What caused the failure of the last vital cultural, educational, and spiritual institution in Vox Populi Texas, a freedom colony in Colorado County, Texas? Why were established balloon framing construction methods consistently compromised during the construction phases? Was this an example of faith over function? The wall failure which ultimately led to the abandonment of the South Point Baptist Church was investigated as part of a study of construction phasing and related compromises to the structural capacity of the structure in the context of balloon framing practices of the time from 1850 to 1920. This investigation was made possible by third-party theft/harvesting of interior sheathing and flooring which has exposed the improvisational wall and floor framing. Archival research on Vox Populi and the South Point Baptist Church was conducted at the Nesbitt Memorial Library, Columbus Texas. Digital models of the church construction phases were developed, and framing detail models constructed of key structural conditions to understand their modificat

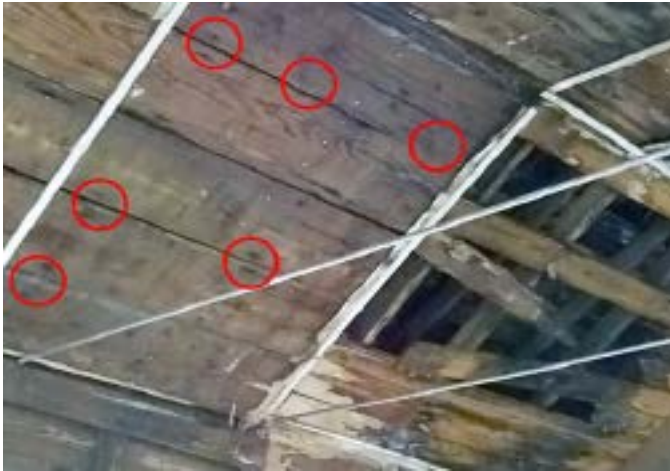
Figure 4. Joint between Phase 1 Meeting Hall and Phase 3 Rostrum Roofs Showing Stains from previous use as the "First" Single-wall Church
Source: Image by Michael O'Brien.

It is possible that the 12-inch-wide ceiling boards found in the ceiling of the South Point church as it stands today, and some floor framing, may have been part of the "first" (1883) South Point Baptist church and were saved for reuse in the "second" church construction in 1923 as the community practice of the "tearing down" of the old and recycling pieces was known and documented by Sitton.¹⁴

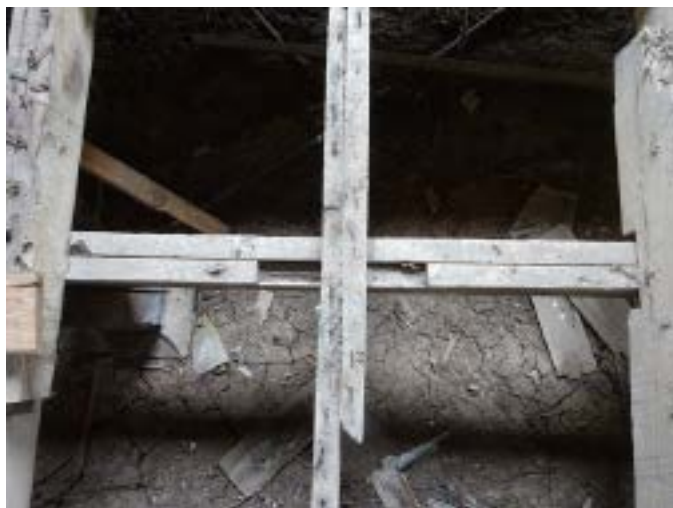
At South Point Baptist, framing used in the floor of the initial phase of the church shows signs of having been cut to frame a roof, (Figure 6) and much of the

walls, and floor structure are constructed from shorter pieces of framing, nailed sided by side, “sistering” to make a longer piece of framing. The reuse of construction materials to build anew is documented by Thad Sitton in “Freedom Colonies.”¹⁵

Figure 6. *Floor Framing with Unused Mortise and Gable End Cut (Phase 1)*

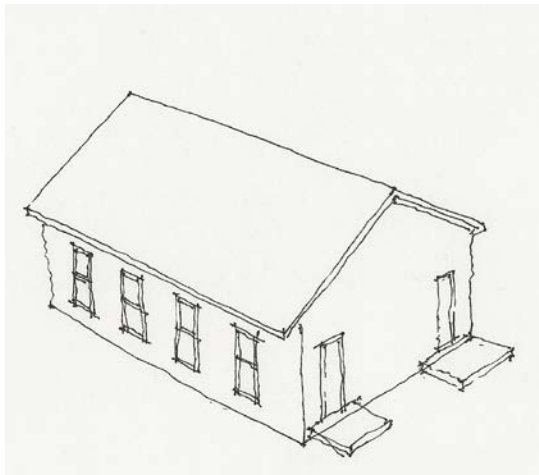
Figure 8. *Phase I Meeting Hall*

As a single-story building, the phase I church is balloon framed with framing members extending from the 4x6 sill to the top plate of the wall. Balloon framing would have been widely known and practiced by the 1923 build date estimate.¹⁹ The corners of the phase one meeting hall have not yet been fully exposed by the

ongoing demolition/material theft but what is visible in both the northeast and southeast corners of this phase 1 construction shows not a solid corner post but a build-up of smaller framing members applied both side by side and on the west face of the corner. This would be consistent with the overall carpentry approach used in the phase 1 church which made extensive use of recycled lumber, possibly from the first church, perhaps from a “tearing down” of a nearby structure. The corner post is braced along the long axis wall with a “down brace” along both the long and short axis of the building. This “down brace” a continuous 2x4 extending from top plate to sill is a critical lateral bracing component that was common in balloon frame construction of this time.²⁰

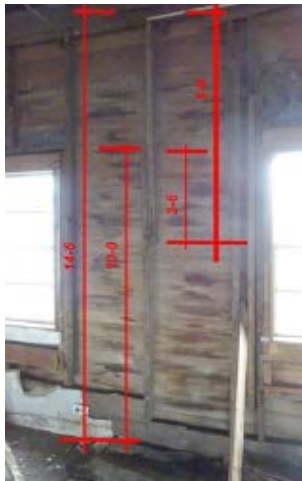
It is likely that most of the lumber used to frame the walls and floor was not purchased or milled for the church project per se. There is evidence that the lumber was reused from another structure, perhaps the result of a "tearing down" wherein the community would disassemble one building to reuse the parts to build another.²² There are floor joists that show unused mortise cuts, and gable end cuts, indicators that the lumber had been reused. Significantly, virtually every wall stud does not extend continuously from the sill plate to the eave plate, depending on the practice of "sistering," where a framing element, like a stud or joist is reinforced by nailing another stud or joist adjacent to it (Figure 10). This practice is still in use in carpentry today, but typically only for damaged stud or joist members. In this case, the entire meeting hall wall and floor structure is made up of sistered members indicating that the members had been reused from another building, perhaps the original church that was not as tall in the sidewall or wide in the floor-span as the current building.

Figure 10. Phase 1 Walls, 8 and 10 Foot Stud "Sistered" to Make a 14'-6 Stud Height
Source: Michael O'Brien Image.

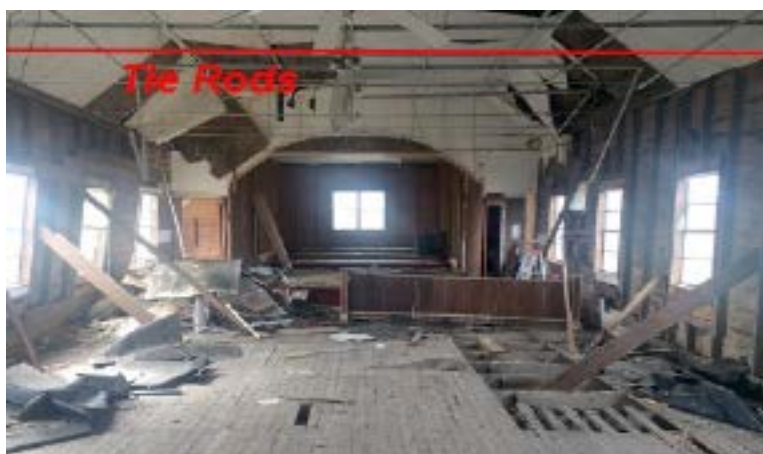
The ceiling is sheathed in 10 to 12-inch-wide boards nailed to the underside of the roof joists as they meet the wall, and then a ceiling joist acts as a tension tie across the sloping roof joists. The net effect is that of a partial “cathedral” ceiling that slopes upwards for approximately four feet extension from the wall, on each side and is flat for the remaining 16 feet in the center of the space. The roof framing above is 2x lumber, informally trussed, perhaps on an “as-needed” basis to prevent excessive deflection in the ceiling joists. Above these trusses are 6-inch boards arranged as “skip” sheathing for a cedar shingle roof. Below the plane of the ceiling, and below the height of the top plate for the wall studs (approx. 14’) one finds six-3/4-inch steel rods with turnbuckles spanning across the space. The spacing of these tie-rods do not correspond to the wall stud spacing and only connect to the shiplap siding, not to studs or the top plate. The absence of disturbance to the interior shiplap sheathing indicates that these tie rods must have been original to the construction. The use of iron rods as ties in wooden constructions dates back to the 12th century and in America dates back to 1833 in bridges and mills,²³ so their use here, while uncommon in balloon framing, is not an unusual innovation.

Figure 13. Interior Demolition 28 Jan. 2017 Showing Tie Rods, Semi-Cathedral Ceiling

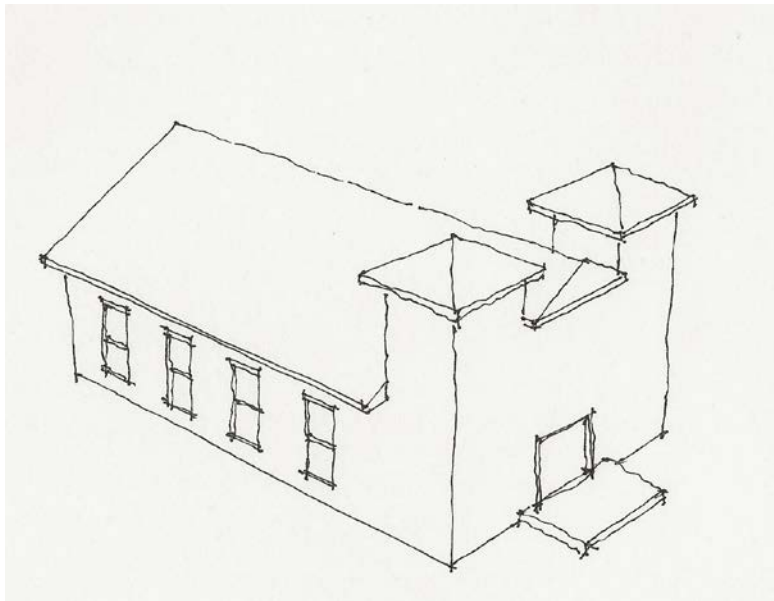
Figure 14. Phase II "Eastworks" Tower and Narthex Addition
Source: Michael O'Brien Image.

Lumber in this phase 2 addition is similarly milled to 2 inches or more in thickness, shows saw marks from the milling process, and is square edged. Easing or radiusing of the edges, common after the postwar period is not visible in this phase. Like the phase I meeting hall portion of the church, no structural panel materials were used as wall or floor sheathing and no framed bracing is visible making these towers dependent on the phase I downbraces for their lateral stability. The exterior 1" thick shiplap siding functioned both as the shear diaphragm of sorts and weather barrier. The towers remain plumb and true as of the date of this article.

The framing techniques used in this addition shares some characteristics with the phase 1 construction in that the framing members are built up, that is, doubled or tripled to achieve both the required cross section required for the 21-foot-tall eave height while being made up of shorter sticks of lumber. The continuity of the overlaps between pieces of spliced lumber differentiates this "building up" technique from the "sistering" technique used in the phase 1 meeting hall where the overlap between side nailed members is often 30 inches or less. Doubled 2x6 members supported the cast bell which was in place in 2010 but has since been removed during the current stripping/demolition of the church.

The evidence for these towers and narthex being a later addition includes: the corner braces in existence in the phase I corner on the west side of the towers. One would wonder why would a carpenter put a “corner brace” effectively seven feet away from the tower corner? My response would be that the presence of the braced meeting hall, but unbraced tower confirms that the carpenter placed the brace in this location because the phase two addition was not yet conceived, and the brace was required to anchor the corner post as traditional balloon framing practice would have it.

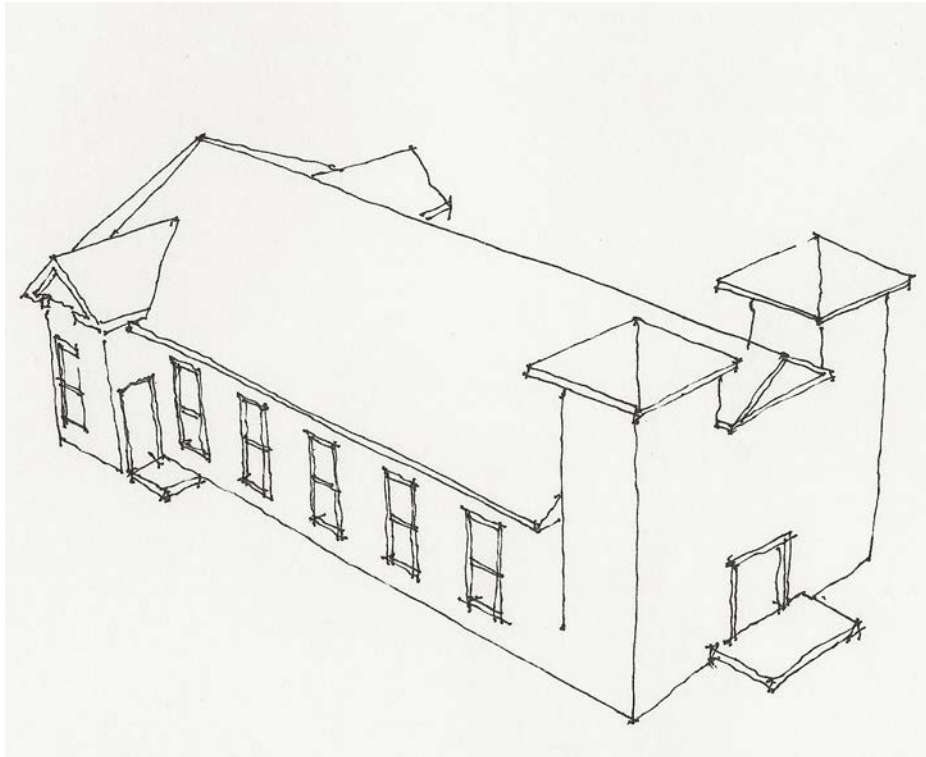
Figure 16. *Phase III Rostrum Addition*

The specific design sanctuary wall of the meeting house phase is difficult to determine as it was completely removed when the rostrum addition was constructed. This act, which removed the downbraces for the southwest and northwest corners ultimately doomed the church. Without the downbraces or compensating framing, lateral forces exerted on the roof from the South levered the wall framing (buckling some sistered studs) and sliding the unrestrained sill to the outside edge of the foundation piers. This unrestrained lateral force resulted in the distortion of the South wall and in nearby roof and floor openings/leaks to the exterior.

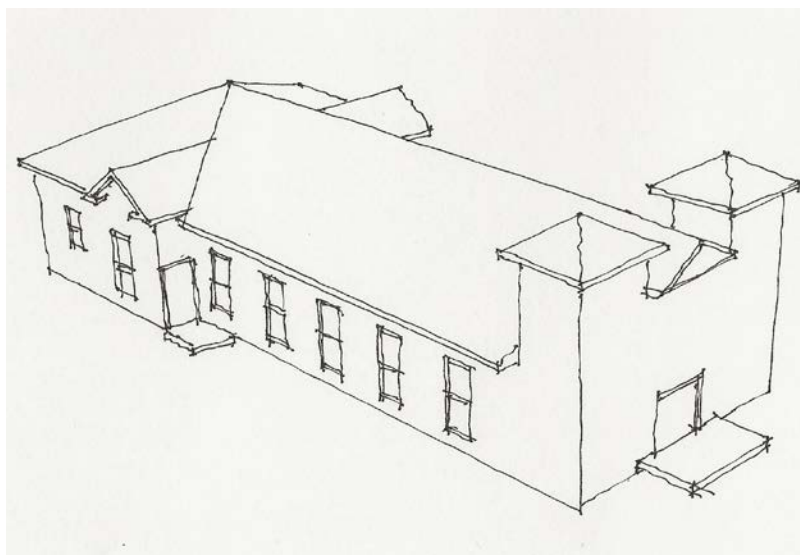
Figure 17. *Phase IV, Choir Addition*

After, perhaps shortly after the 1923’s Rostrum addition, an extra 8’x33’ was added to the west wall of the rostrum. This addition included men’s and women’s toilets, and a rostrum-wide 3-riser choir space. The framing lumber and wall sheathing closely matches the rostrum construction but clear joints in the shiplap wall sheathing and distortions in the roof surfaces show that this was an independent addition installed following the 1923 rebuilding by Reverend A.E. Combs. The cement asbestos siding that covers the south, west and east sides of both the phase 3 (rostrum) and phase 4 (choir) additions were likely part of a later maintenance project, perhaps the project that replaced the 7’6 high windows with the current 6’6” high steel frame units, as the cement asbestos siding shows no indication of patching of a taller opening.

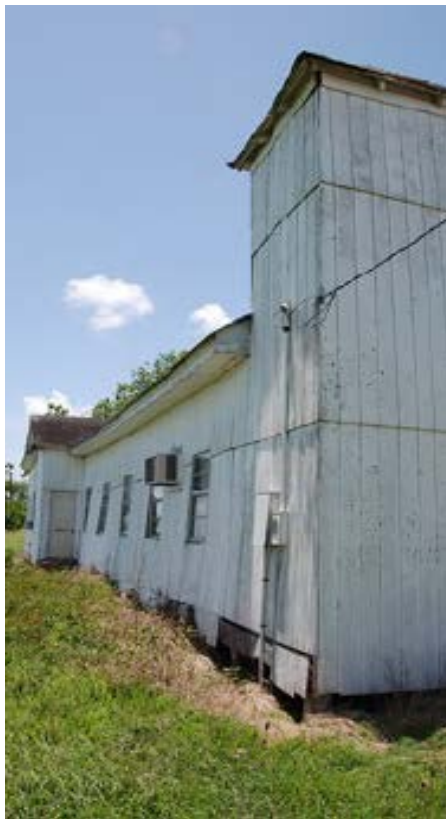
church, which based on trophies visible in 2014, was still a vibrant congregation up through 2007. The sill/wall connection along the western wall shows evidence of extensive water and insect damage, perhaps leading to the rotting of the corner post base and sill connection, thus "freeing" the southern sill beam to move and the attached southern wall to lean precariously.

Parties unknown began removing the contents of the church, its cornerstones and much of the interior shiplap siding by July 2014. The unknown demolition crew installed temporary bracing to compensate for the removal of materials, and in the process exposed the construction of much of the interior walls which made observation of construction, and evaluation of phasing possible. As of February 2019, the church, in this partially demolished state, continued to stand. When South Point Baptist finally falls or is demolished, the last institutional anchor of Vox Populi will be gone and the noble aspirations of 124 years of residents will become little more than a brush pile along Highway 71

Figure 18. *South Wall of South Point Baptist Showing Distortion*
Source: Michael O'Brien Image.
