Time and Material. Interdisciplinary Study for Dating St. Francesco Convent in Cagliari (XIII-XXI Century)

By Caterina Giannattasio*
Silvana Maria Grillo†
Valentina Pintus‡

This study concerns the Franciscan monastery, situated in the historic centre of Cagliari (Sardinia, Italy). It was founded in the 13th century, and transformed up to the present day. Its historical-stratigraphical complexity and the lack of data about its evolution led us to carry out an interdisciplinary inquiry. The investigation began with the use of a laser scanner survey aimed at defining a chronological hypothesis applied to the building which was based on reconstruction of historical maps, examination of masonry techniques and stratigraphic analyses. The dating obtained led to the choice of masonry samples to compare with other local and contemporary buildings where the chronology is well-known with the aim of confirming previous hypothesis. Analysis of the masonry samples allowed an understanding of their actual structure and composition, with reference to specific historical events. The mineralogical-petrographic characterization of building materials was essential. Plaster and mortar have been studi

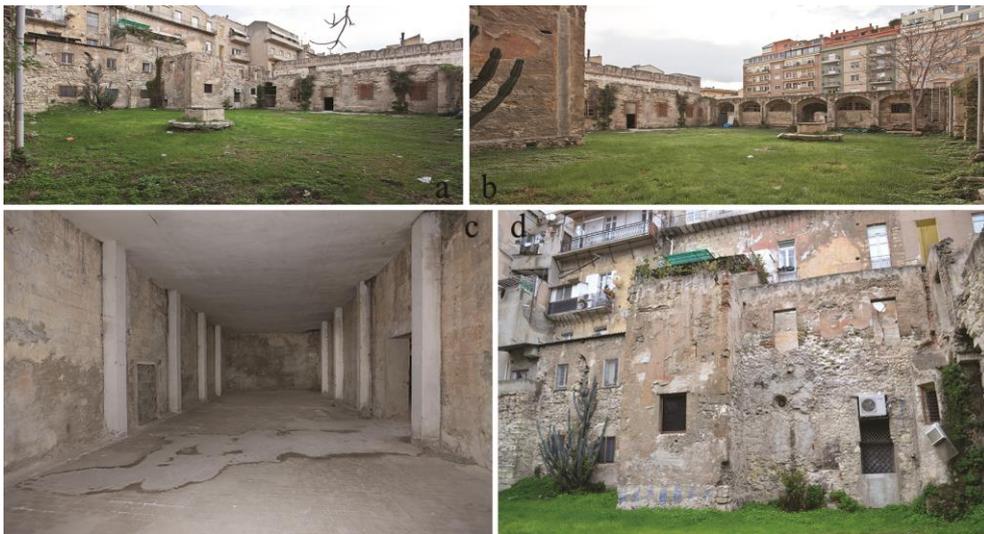
Figure 2. *The Cloister's Area (a-b-d) and the Inside of the Refectory (c)*
Source: Author Aldo Vanini.

As we said before, because of the succession of many events, it is now in an advanced state of decay. It only retains the ground floors of the eastern, southern and western parts which define the cloister area (see Figures 2a-b), and the west side, which originally housed the refectory (see Figure 2c). The northern part is the only one that has kept its upper level (see Figure 2d), although completely embedded in the newer buildings built in the late 19th century, consequent to the demolition of the church and the urban renewal of the area. Also, the southern part of the cloister is very compromised, having been partially demolished in order to open a new street in the middle of the 20th century.

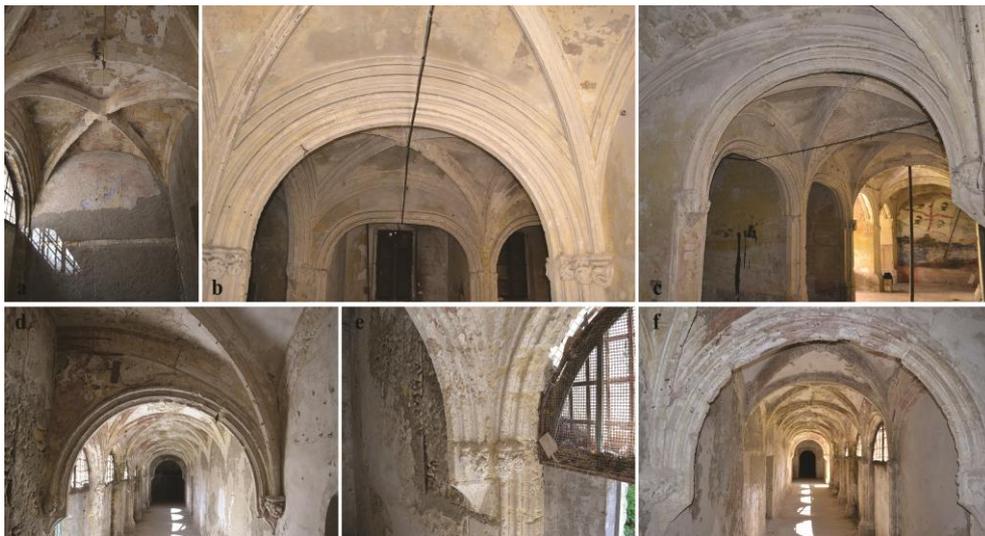
Figure 3. *The System of Vaults and Arches of San Francesco Convent*

The buildings that delimit the cloister on the north, south and west sides are characterized by a very simple decoration, with arches between the spans and crossed vaults with pendula (see Figure 3a). The west side is connected with the former refectory.

size and form. The two parts are connected by arches of different typologies (see Figure 3b).

The buildings facing the cloister show a floor plan articulated in square modules (see Figure 3c), with crossed vaults held up by finely decorated pillars and capitals (see Figure 3d), with some variants, caused by the subsequent stratifications which clearly compromised the original homogeneity of the architectural complex.

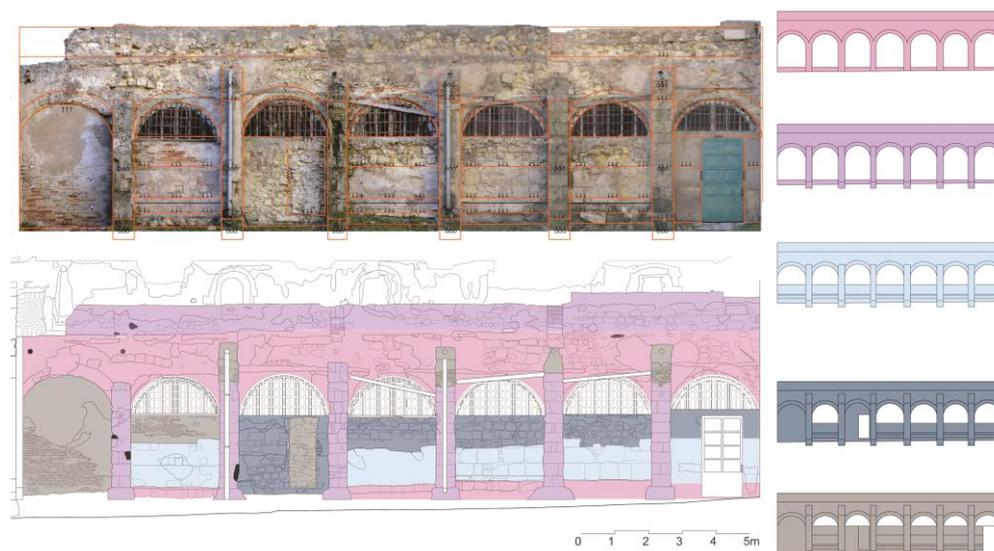
Figure 4. *The West Facade: Stratigraphic Analysis of the Structures, Dating and Transformations Hypothesis*

In detail, the stratigraphic method³ was divided into three main phases: a) identification of stratigraphic units (masonry stratigraphic units - msu; surface stratigraphic units - ssu; negative stratigraphic units - nsu); b) definition of connections between the stratigraphic units in order to establish diachronic or synchronic relationships between the parts; c) construction of a relative chronology between the same units (see Figures 4-5).

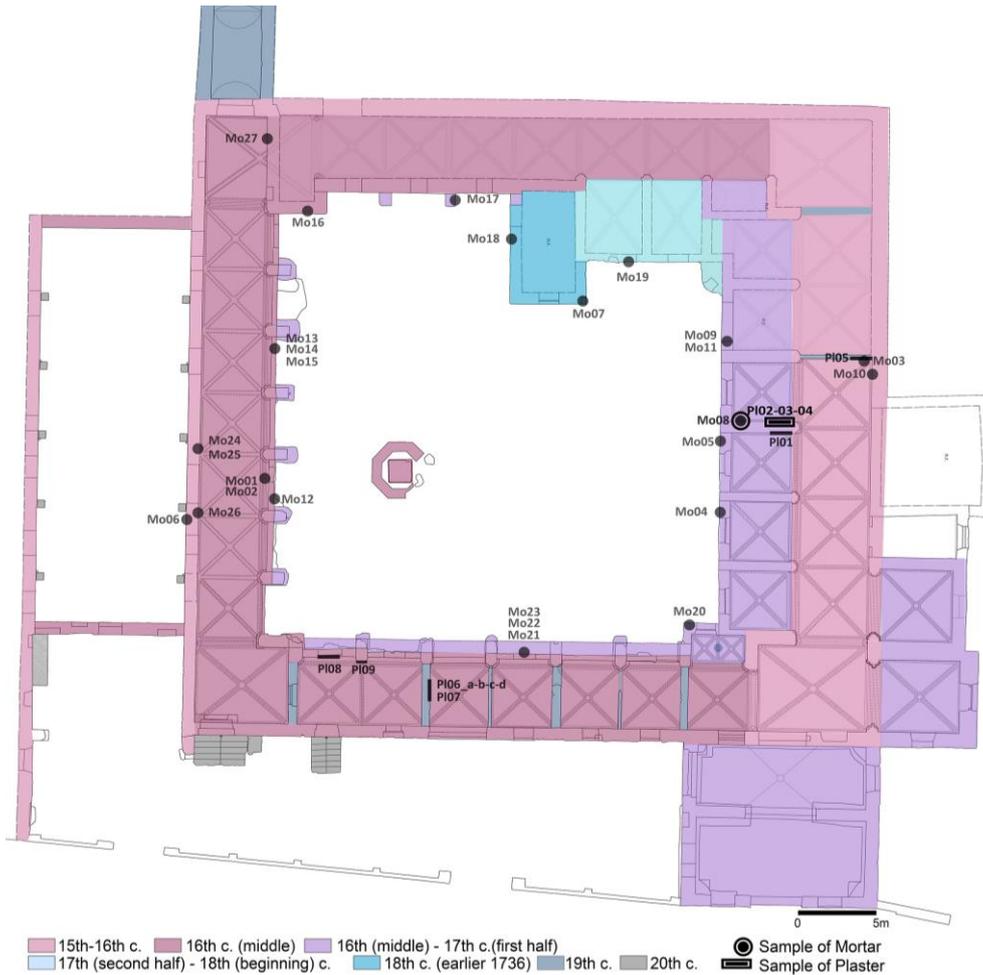
Figure 5. *The First Floor Plan of the Complex with Dating Hypothesis and Indication of Material Samples Analyzed*
