## Knowledge for Conservation: Architectural Archaeology for Understanding the Static Behaviour – The Case of the Brandale Tower in Savona

By Daniela Pittaluga\* & Camilla Sbardella<sup>±</sup>

### The Brandale Tower in Savona (IT)

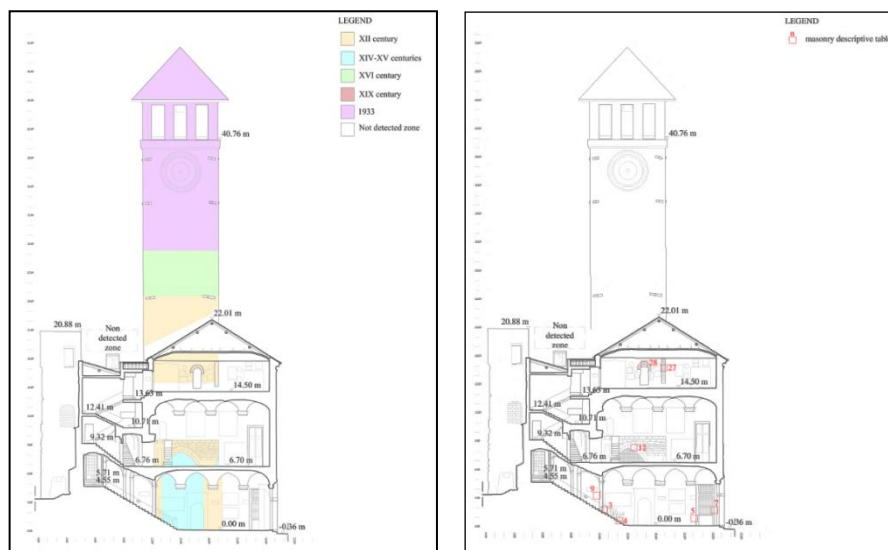
**Figure 2.** Brandale Tower: Material Map (Fig. 2a) and Stratigraphic Units (S.U.) (Fig. 2b)

was organised into a hierarchy: first, the significant stratifications of volume were described and analysed, i.e. those with major changes in volume, then the changes that may have affected the horizontal structures (floors, vaults), then the changes that affected the openings/closures of doors and windows, and finally the visible layers in the coatings (successive plastering, multiple layers of paint, etc.). Only after gaining such a precise understanding of the historical object was an analysis of the currently visible cracks carried out. In this study, since the client's (Associazione "A Campanassa") primary concern was to understand the real danger or otherwise of structural instability in the tower, we wanted to introduce a variable that is not usually included in this context: in this case, a stratigraphic study of the cracks was carried out, so to speak, i.e., an attempt was made to determine which cracks showed traces of previous grouting and which did not. In this way, it is possible to obtain a preliminary overview of the instability over time (details on this aspect are provided in the next paragraph). Cracks with traces of old grouting are a sign of instability that occurred in the past and was remedied, cracks with traces of plastering but which have reopened indicate that the cause that had caused them in the past has reoccurred, cracks without any traces of plastering are the most recent cracks, the cause of which has not yet been remedied, and then the effect produced. In order to determine the chronology of the onset of the cracks, it can sometimes be useful to compare the stratigraphy of the coatings and masonry: in these cases, and not always, it is only possible to obtain a date ante or post quem.<sup>16</sup>

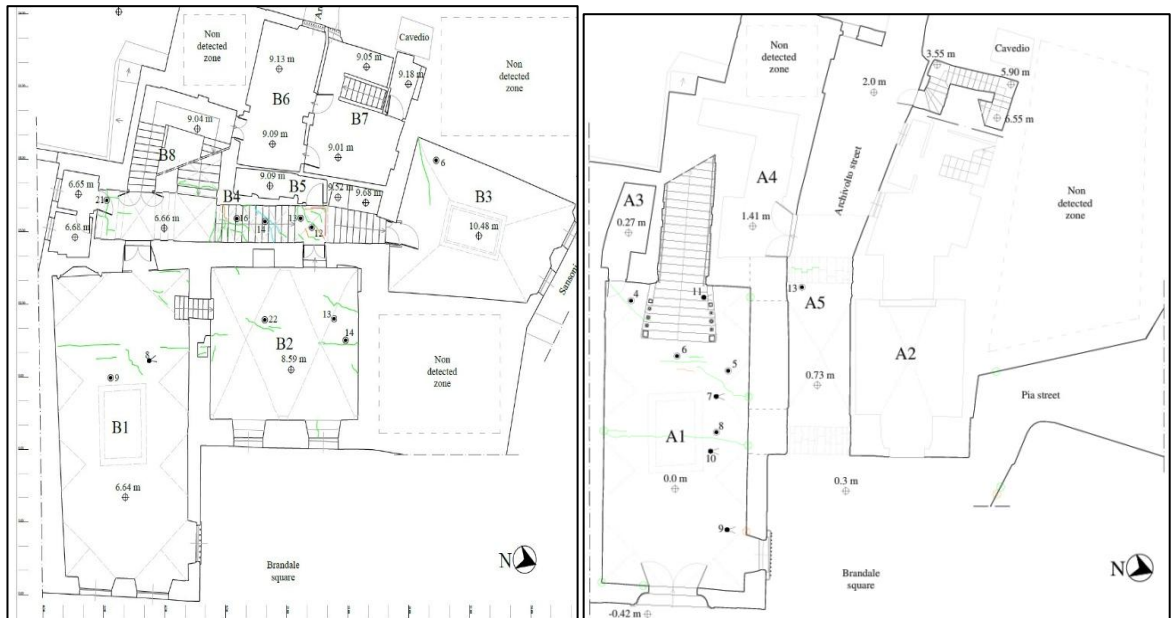
**Figure 3.** Plan of the Ground Floor – Crack Pattern of Vertical Elements.

At the ground floor (Figure 3), thin cracks were mainly observed in the northern wall of room A1, where they correspond to material discontinuities and local installations. Moisture decay was also evident, with efflorescence, flaking of the plaster and deterioration of mortar joints, probably connected with rising damp and with the cistern below the tower. At the first floor (Figure 4) the crack pattern becomes more extensive.

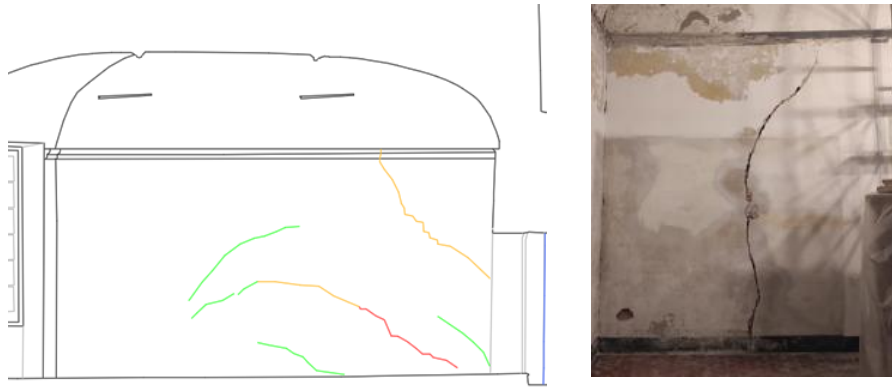
**Figure 5.** Crack Western Wall in Room B3

In room B1, cracks are associated with the joint between the tower and the Palazzo degli Anziani and with the infill of former openings; a medium vertical crack on the southern wall continues into the vault. In room B2, thin cracks occur around closed openings and at wall-vault junctions. Room B3 showed medium and large diagonal cracks, now covered by the 2021 repairs, which can be interpreted as the effect of past settlement rather than as evidence of an active mechanism (Figure 5).

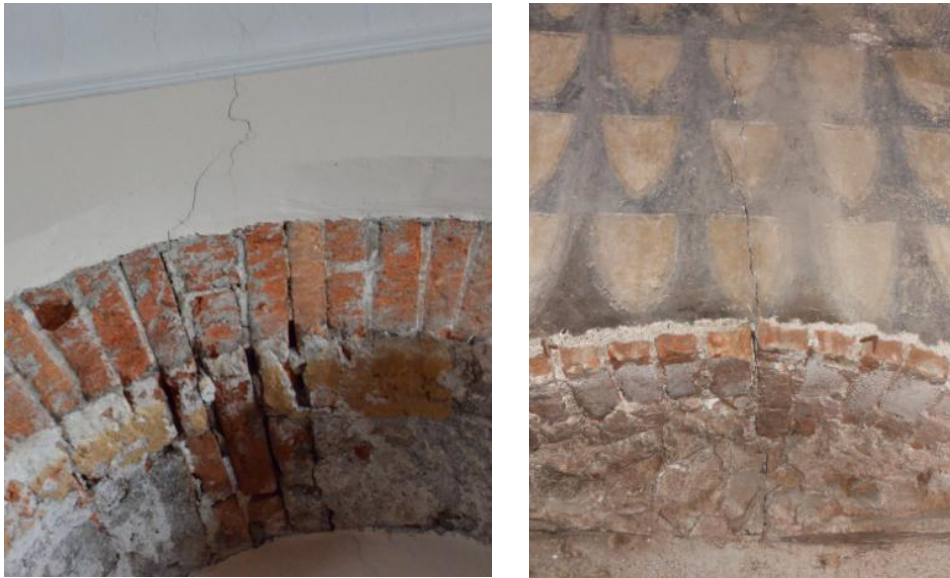
**Figure 7.** *Vertical Cracks on the Opposite Side of the Wall Above the Niches in Rooms C1 (left) and C2 (right)*

Moisture-related decay had also affected the vault and walls of room B3. In room B4, cracks correspond both to old openings and to technical installations. In stairwell B8 and in room B6, vertical and diagonal cracks at wall intersections suggest weak connections between different building portions, especially where the tower, the Anziani Palace and the Gambarana Tower meet. On the second floor (Figure 6), cracks in room C1 are concentrated at corners and at the niche facing room C2, confirming the role of discontinuities and imperfect wall-to-wall connections (Figure 7).

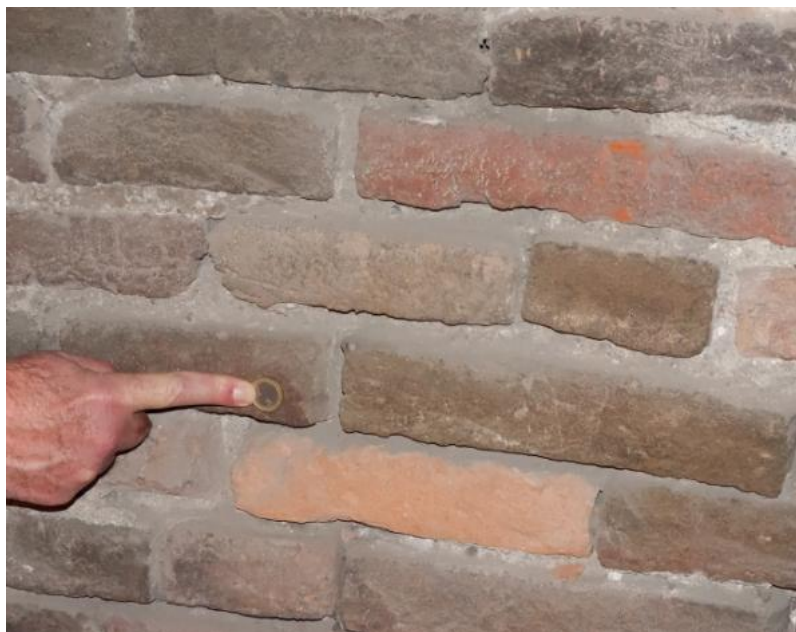
**Figure 8.** *Enlargement of the Window, Vertical Crack Above the Window and Worn Mortar Joints*

Moisture damage was also observed. Room C2 is particularly significant: its walls show masonry losses, worn mortar joints and a vertical crack above the eastern window, visible on both the inner and outer faces. The enlargement of the ogival window for the passage of the bell probably increased the local vulnerability of this wall (Figure 8). Rooms C5 and C6 show minor cracks and moisture problems, probably related to inaccessible neighbouring apartments.

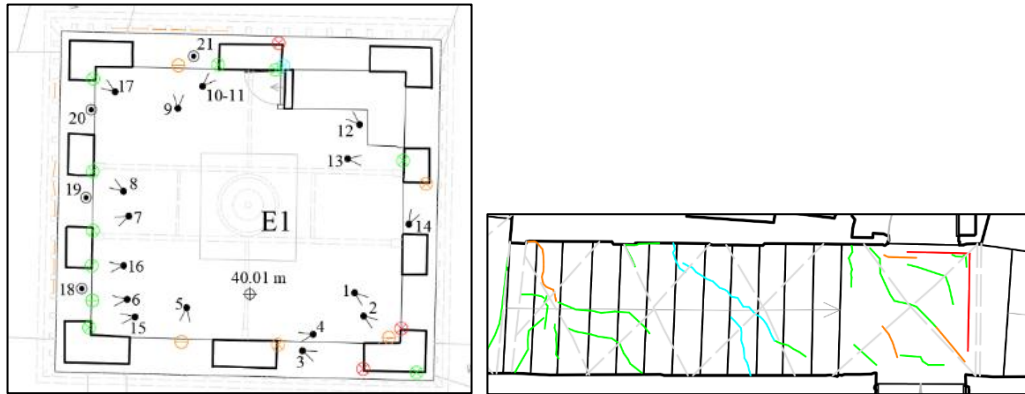
**Figure 10.** Plan of the First Floor - Crack Pattern of the Vault in Space B4.

cracks are present in the vaults of rooms B1, B2 and B3. The extrados of the vault in room B2 is not perfectly horizontal, with differences greater than 10 cm, but this appears to be related to construction irregularities rather than ongoing movement. The vault of room B3 was affected by water infiltration before the 2021 repair. In space B4 (Figure 10), several cracks, some previously grouted, show that this vault had already required local intervention.

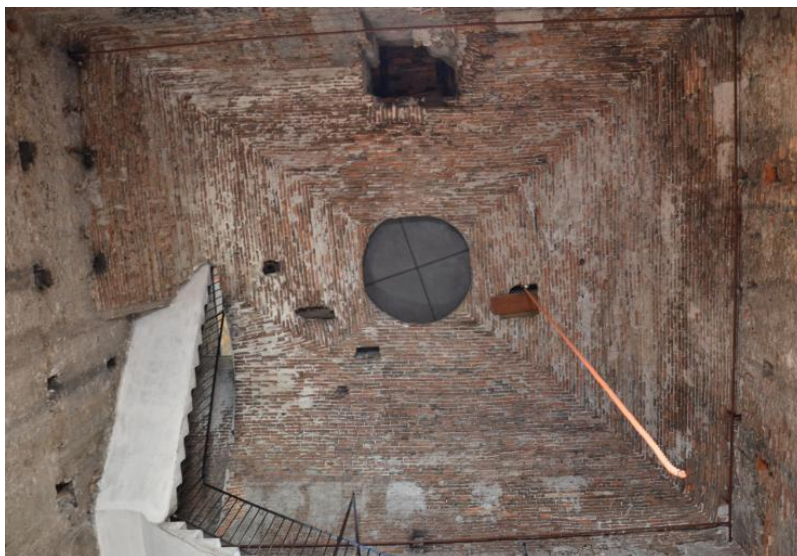
**Figure 11.** *Intrados of the Vault in Room C2.*

On the second floor, thin cracks affect the false ceilings of rooms C3-C6. Room C1 is the most critical, with widespread cracking and damp stains, probably related to construction defects identified in 2015. The vault of room C2 has no relevant cracks, although local masonry gaps are visible and the extrados is uneven (

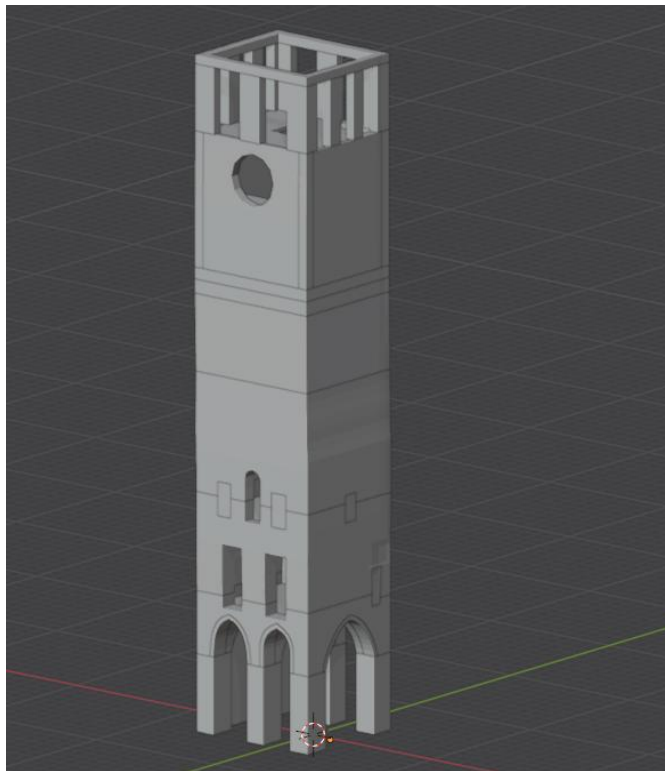
**Figure 12.** *Model of the Tower Realized in Blender*

The FE geometry was derived from the laser-scanner survey and from the AutoCAD drawings. The three-dimensional solid model was first reconstructed in Blender and then imported into ANSYS (Figure 12).
