Study of Erosion Control Techniques Applied to Hydroelectric Power Plants Reservoir Margins

By Terezinha C. De Brito Galvão*
Arnaldo Teixeira Coelho†
Gustavo Borel de Menezes‡
Ênio M. Brandão de Fonseca♦

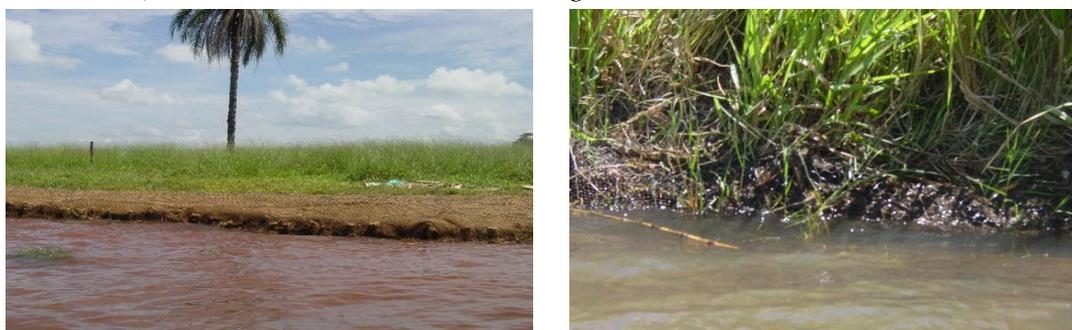
Figure 1. a) *Coconut Fiber Biologs Covered by RECP from Deflor, at Pier, in 2002* and b) *Same Area with Consolidated Vegetation, at Pier, in 2007*

Figures 1 to 3 depict the implementation of the selected bioengineering treatments, and at after the vegetation growth.

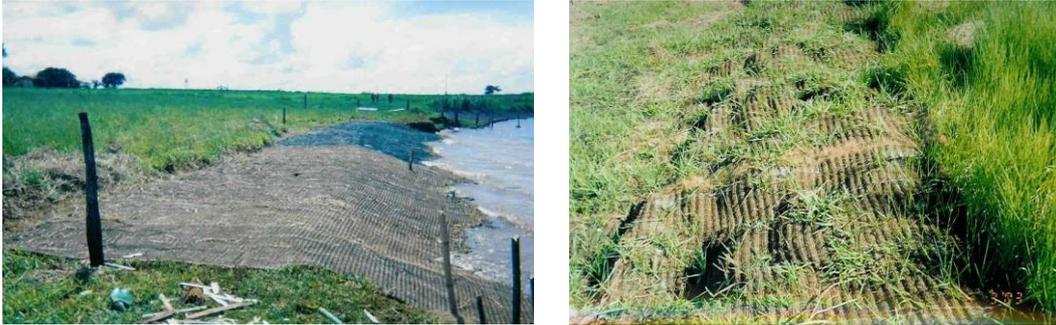
Figure 2. a) C350 from NAG/USA in 2002 and b) C350 from NAG/USA at Beginning of Consolidating the Vegetation

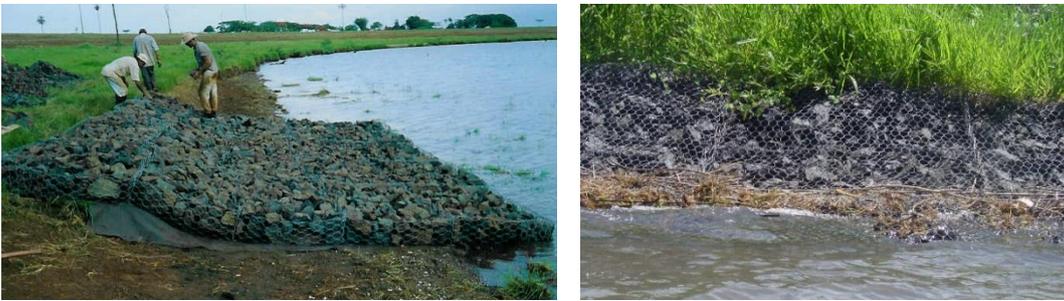
Figure 3. a) Implementation of Gabion Mattress in 2002 and b) Gabion Mattress at Beginning of Vegetation Consolidation in 2004

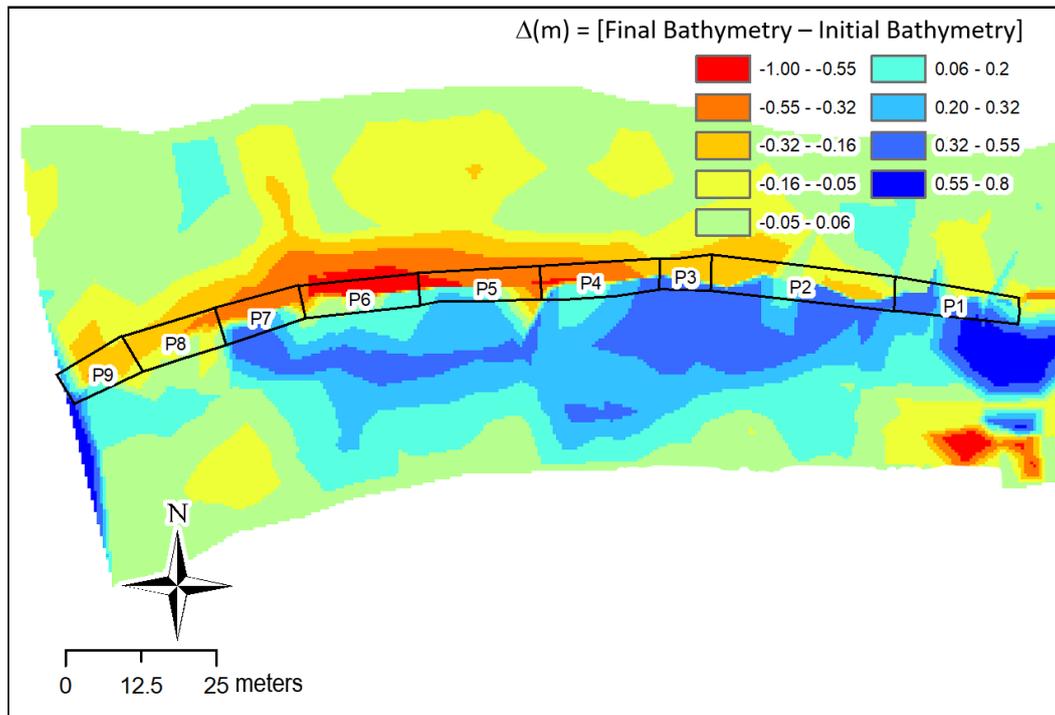
Figure 4 shows the differential bathymetry plotted using ArcGIS.

Figure 4. Differential Bathymetry Plotted using ArcGis, in where P1 – Vegetated Biologs (Filled with Straw) + Sintemax Geotextile from Deflor Bioengineering/Brazil; P2 – rip-rap; P3- rip-rip + bag Gabion; P4- MacMat Geotextile from Maccaferri/Brazil + bag Gabion; P5- rip-rap + Gabion Mattress; P6 – Gabion Mattress + MacMat Geotextile from Maccaferri/Brasil; P7 – rip rap; P8- Geotextile P550 from North American Green/USA; P9 - Geotextile C350 from North American Green/USA

It was decided then to use differential bathymetry (final bathymetry – initial bathymetry) developed using in ArcGIS map algebra, to identify soil loss/accumulation in front of each treatment.

According to this differential bathymetry the treatments with less soil deposition in front of them were as follows: P6, P8, P9, and P5.
