Marine Propeller and Rudder Cavitation Erosion from Full Scale Observations and the Results of a Research Programme

By Ioannis Armakolas*
John Carlton[‡]

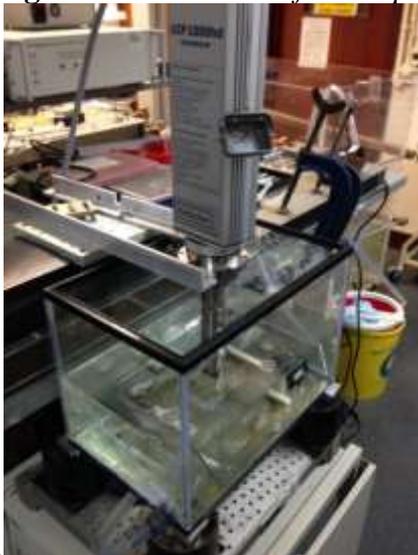
The main aim of this study commanded that, the under experimental investigation, specimens would have to be placed in a cavitating liquid medium (water) thus an appropriate test rig was built, essentially consisting of a plastic water tank, a base plate (bridge) for the specimens and a cavitation excitation source by means of an ultrasonic transducer (Figure 1).

Figure 1. *Illustration of the Experimental Test Rig*

The under-investigation specimens, shaped in small rectangular plates, were mounted onto the base plate, positioned at the bottom of tank, which was then filled with fresh water. The head of the ultrasonic transducer (sonotrode) was placed just above each specimen's surface at a predetermined distance of 1mm. The base plate, as well as each specimen, had got markings to ensure correct placement, every time a specimen was taken out for measurements.

With regards to the cavitation excitation source, the operating principle of the ultrasonic transducer is based on the reversed piezoelectric effect thus longitudinal

mechanical oscillations at the tip of the sonotrode are generated by electrical stimulation. The frequency of those mechanical oscillations is set at 20 ± 1 kHz whereas the power output of the ultrasonic transducer can be adjusted throughout the range between 50 and 100% of its maximum power output which is 1000W. The titanium made sonotrode is mounted on the horn of the ultrasonic transducer where it functions as a $\lambda/2$ oscillator thus it increases the amplitude of those longitudinal mechanical oscillations up to amplitude of 150 μ m. Mechanical oscillations of that order transmit pressure fluctuations into the water, of sufficient amplitude to induce erosive cavitation, via the front face of the sonotrode (tip).

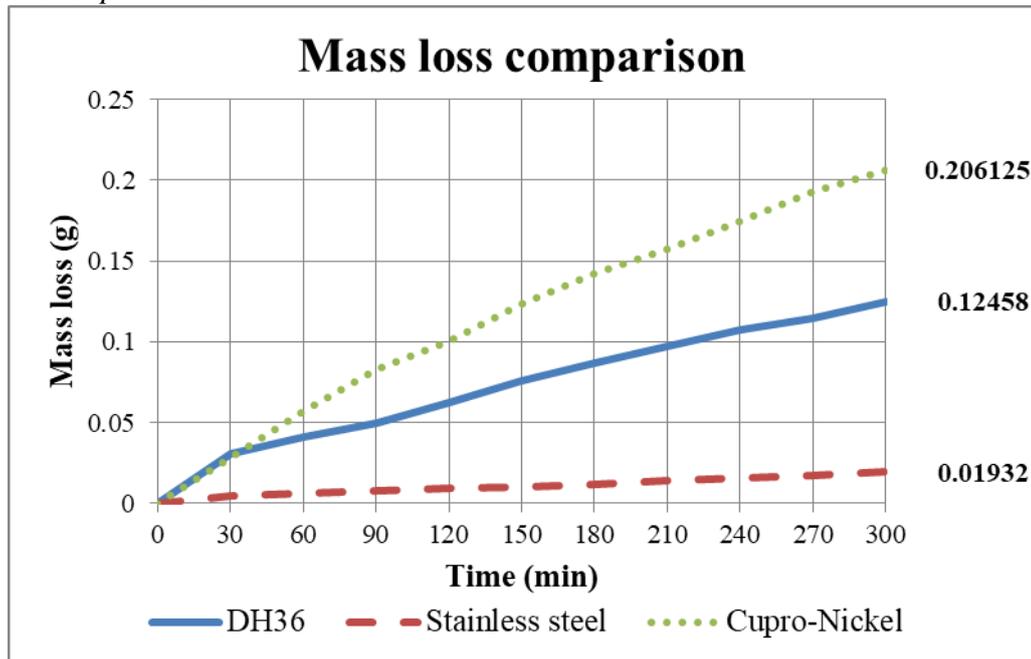
Figure 2. Mass Loss Comparison between Grade DH36 Steel, Stainless Steel 254 and Cupronickel 70-30

It can be clearly seen that, in general, there is an increase in terms of mass loss for all examined alloys due to continuous ultrasonically induced cavitation exposure. Different slopes with regards to the mass loss lines, however, indicate dissimilar rates of mass loss, between the alloys.

The accumulated mass loss at the end of the five (5) hours exposure due to ultrasonically induced cavitation was:

- 0.01932g for stainless steel 254
- 0.12458g for grade DH36 steel
- 0.206125g for cupronickel 70-30

Results indicate that, with regards to the measured mass loss, stainless steel 254 was remarkably resistant against ultrasonically induced cavitation erosion, followed by grade DH36 steel and cupronickel 70-30.

Interestingly, grade DH36 steel and cupronickel 70-30 exhibited an identical behaviour for the first thirty (30) minutes of exposure, with regards to the measured mass loss. Nevertheless, grade DH36 steel demonstrated a more resistant nature compared to cupronickel 70-30, for the rest of the procedure, possibly due to work hardening effects and different properties.

With regards to the examined materials and in terms of the resulting erosion – mass loss against ultrasonically induced cavitation, stainless steel 254 exhibited the best behaviour followed by grade DH36 steel and cupronickel 70-30. That difference could possibly be explained by the different mechanical properties of the materials, with stainless steel 254 for instance having a tensile strength of the order of 680 MPa whereas the relevant values for grade DH36 steel and cupronickel 70-30 are 490 MPa and 360 MPa, respectively. It is also noteworthy that grade DH36 steel and cupronickel 70-30 lost the same amount of mass after 30 minutes of cavitation exposure, thus exhibited an identical behaviour. Nevertheless, from this point to the end of the procedure grade DH36 steel performed better in the sense that it was constantly losing less mass compared to cupronickel 70-30 whereas its accumulated mass loss after five (5) hours was also significantly lower.

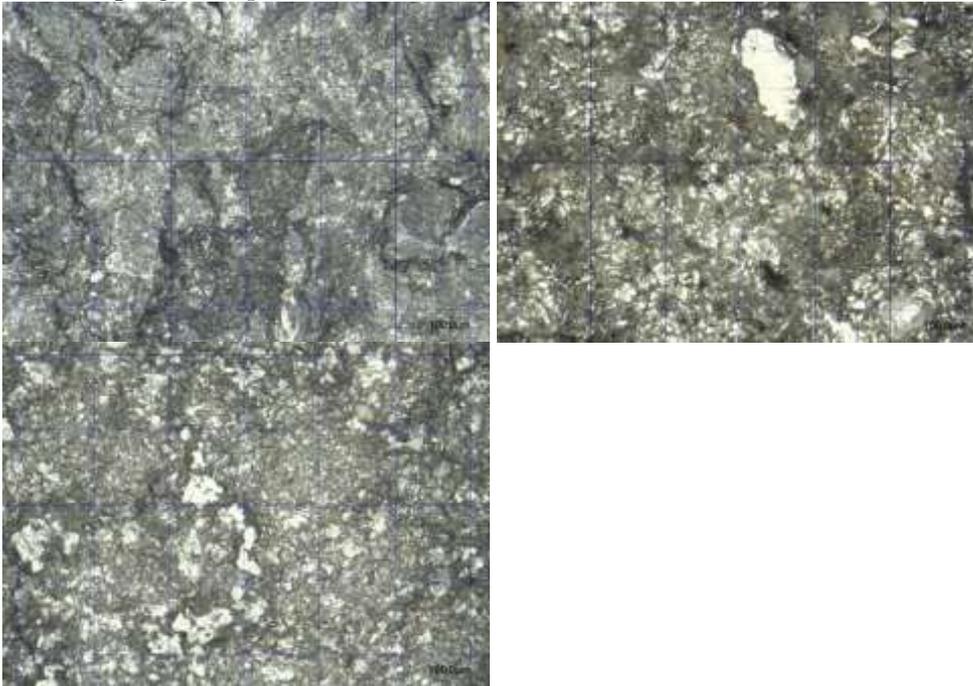
Initially, all eroded alloys were examined under the lens of a digital optical microscope under a x500 magnification in order for some general observations regarding the dominant type of fracture (brittle or ductile) to be made (Figure 3).

Figure 3. *Microscopic Appearance of All Eroded Alloys (Top left) Grade DH36 Steel (Top right) Cupronickel 70-30 (Bottom) Stainless Steel 254*

By examining the relevant microscopic images, it was found that the eroded surface of stainless steel 254 was granular whereas it was dominated by characteristics such as sharp bumps and distinctive reflective facets, thus indicating that fracture was mostly brittle in nature. The same apply for grade DH36, where well-defined facets as well as nearly straight edges dominated the erosion pattern, thus indicating an extensive amount of brittle fracture. In this case, however, signs of plastic deformation were also apparent, in the form of small ductile dimples. Finally, the eroded surface of cupronickel 70-30 revealed an almost equal number of signs of both brittle fracture and plastic deformation. In particular, well-defined reflective facets in conjunction with ductile dimples were apparent all over its eroded surface.

Microscopic examination under the lens of the optical microscope revealed that, the steel alloys suffered from fracture of a more brittle nature, as it was represented by several well-defined facets, whereas cupronickel revealed signs of severe plastic deformation in the form of large ductile dimples. Further examination by means of a scanning electron microscope (SEM) essentially confirmed the aforementioned assumptions whereas it also revealed some additional characteristics relating to the way cracks propagated inside the examined materials. In particular, the presence of numerous bumps and ridges on the surfaces of grade DH36 steel and stainless steel 254 suggested that transgranular (crack propagation through the grains) brittle fracture was the dominant mode whereas the presence of well-defined facets suggested that intergranular (crack propagation through the grain boundaries) fracture also took place although to a lesser extent. Some signs of plastic deformation were also apparent in both cases, in the form of small and isolated ductile dimples. Cupronickel 70-30 in contrast, exhibited a different behaviour, with its surface being characterized by severe plastic deformation in the form of ductile dimples of all sizes whereas an amount of intergranular brittle fracture could also be present in the form of facets closely resembling the grains of the material. Similar to the mass loss measurements, there was good correlation between the mechanical properties of the materials and the resulting erosion, in the sense that strong alloys such as grade DH36 steel and stainless steel 254 exhibited fracture of a more

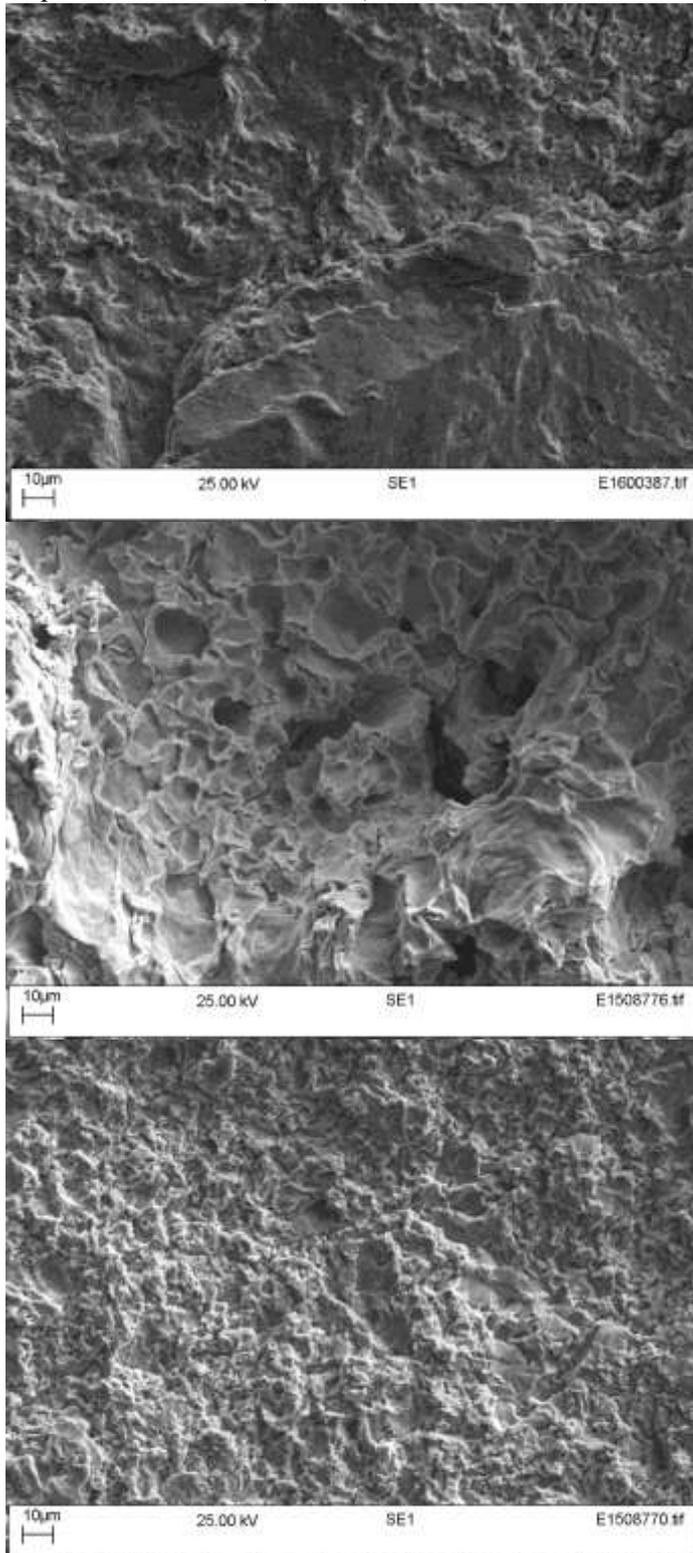
Figure 4. SEM Images of All Eroded Alloys (Top) Grade DH36 Steel (Middle) Cupronickel 70-30 (Bottom) Stainless Steel 254

In general, examination of the SEM images confirmed all initial estimations regarding the observed fracture types (brittle or ductile), nevertheless, with the addition of some noteworthy remarks, relating to the fractography of each one of the examined materials.

In the case of cupronickel 70-30 for instance, signs of plastic deformation in the form of ductile dimples of all sizes were clearly apparent all over its surface. Signs of brittle fracture could not be identified as clearly although they were possibly apparent in areas, closely resembling the individual grains of the materials, in the form of intergranular brittle fracture (crack propagation through the grain boundaries). The surface of stainless steel 254 on the other hand was mostly dominated by signs of transgranular (crack propagation through the grains) and to a lesser extent intergranular brittle fracture. The former is characterized by ridges and smooth bumps, whereas the latter is characterized by well-defined facets. Signs of plastic deformation were also apparent, in the form of isolated tiny ductile dimples. On a similar note, signs of mostly transgranular and to a lesser extent intergranular brittle fracture dominated the surface of grade DH36 steel, in the form of ridges and well-defined facets, respectively, however, in comparison to stainless steel, the appearance of those ductile dimples was more frequent thus indicating an increased amount of plastic deformation.

In general, microscopic and SEM observations were in good agreement, while there appears to be a connection between the accumulated mass loss and the observed fracture patterns. In particular, it appears that, increased amounts of mass loss are possibly related to plastic deformation, as it was the case for cupronickel 70-30, whereas the opposite is also true, as it was represented by stainless steel 254, for which characteristics of mostly brittle fracture were observed. Grade DH36 steel, which can be ranked between cupronickel 70-30 and stainless steel 254, with regards to measured mass loss due to ultrasonically induced cavitation erosion, exhibited signs of both brittle fracture and plastic deformation, fact that further reinforces the aforementioned assumption.

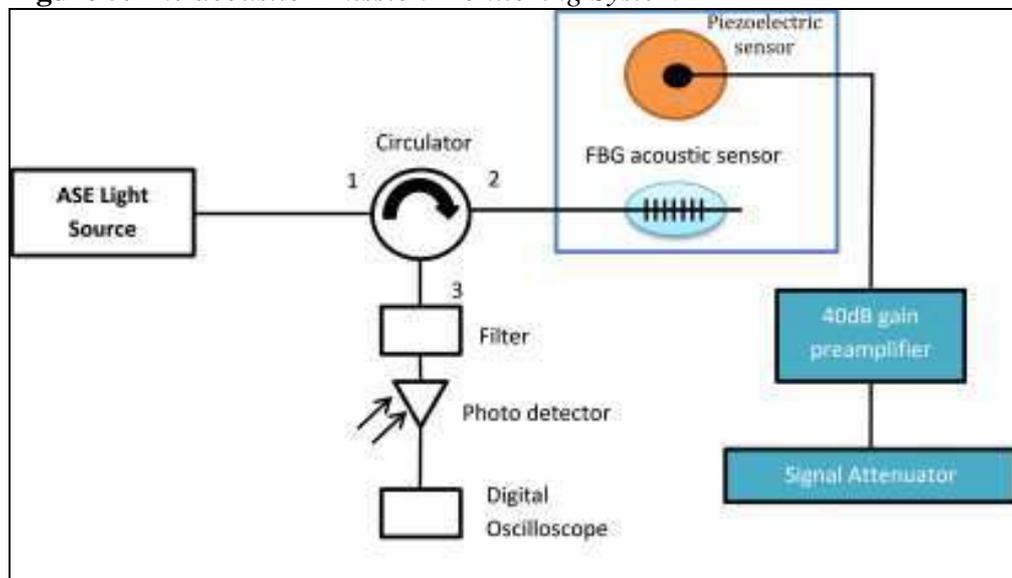
Acoustic emissions were measured by means of a system based on piezoelectric acoustic sensors whereas the use of fibre Bragg gratings (FBG) was also explored. Piezoelectric sensors operate on the principle of piezoelectricity, which is the ability of some materials to produce an electrical charge in response to mechanical stress (Gautschi, 2002), whereas fibre Bragg gratings are essentially optical sensors that reflect a specific wavelength of light and transmit all others, thus any induced mechanical strain results into a reflected – wavelength shift that can be measured (Othonos and Kalli, 1999). FBGs can especially be utilized in harsh environments due to their immunity to electromagnetic interference, small size, cost and chemical inertness (Mihailov, 2012; Tsuda et al., 2013). They have even been installed in an experimental marine propeller with promising results (Javdani et al., 2016). Piezoelectric acoustic sensors can be used either actively, thus the sensors would generate ultrasonic signals (Giurgiutiu, 2003) or passively, thus the sensors would detect ultrasonic signals (Mal et al., 2003) which is the case in this study.

The acoustic emission monitoring system that was assembled for this study, can be seen in Figure 5, showing both piezoelectric and FBG elements.

Figure 5. *The acoustic Emission Monitoring System*

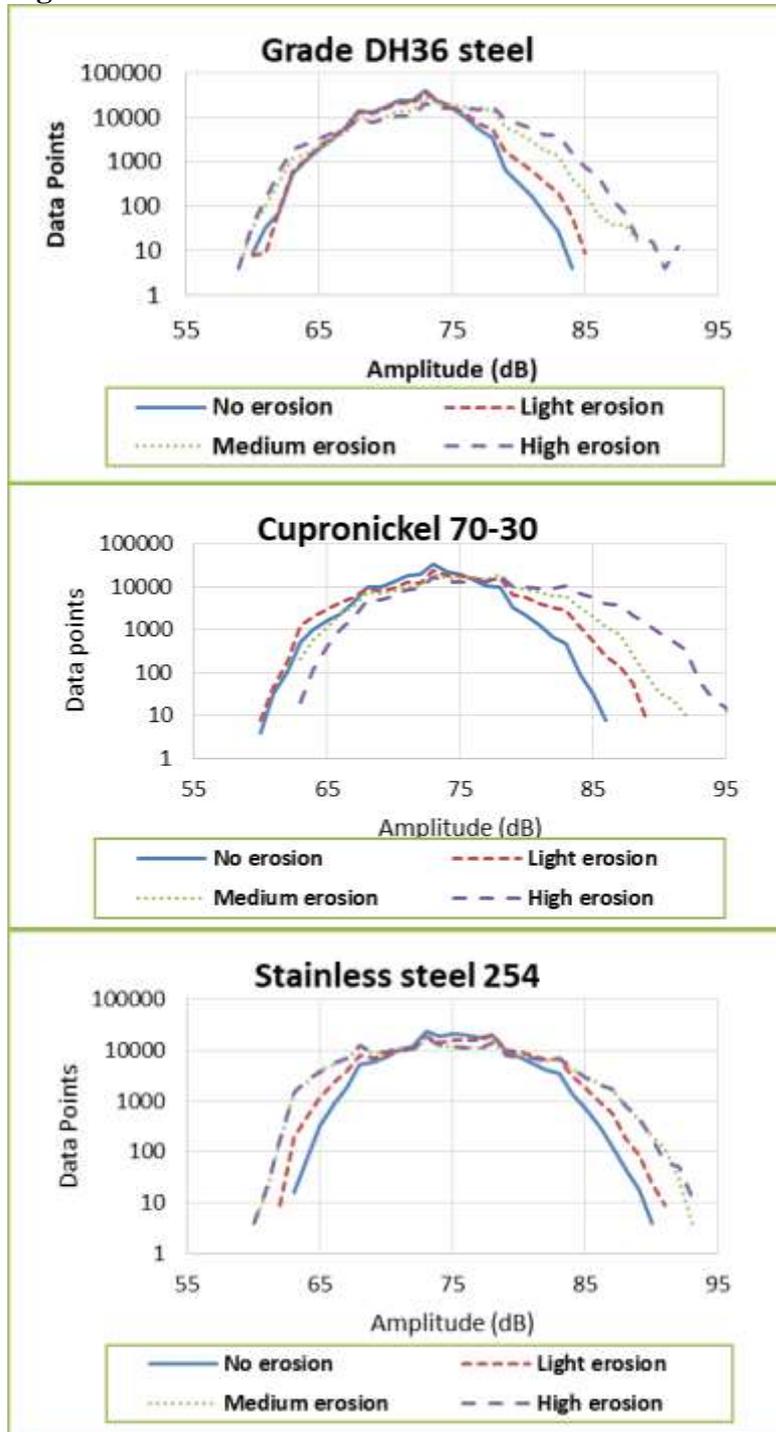
Results for each one of the alloys were plotted onto dedicated graphs, each one containing acoustic data, in terms of acoustic power, for four (4) different test rig configurations (Figure 6). In addition, a fast Fourier transform (FFT), relating to signals from both piezoelectric and FBG sensors is also presented,

Figure 6. Acoustic Emission Measurements

With regards to acoustic emission data, it can be seen that the transition point between ‘non-erosive’ and ‘erosive’ cavitation can be clearly identified for all alloys. In particular, the transition point for grade DH36 steel is 85 dB in terms of acoustic power units, whereas for cupronickel 70-30 and stainless steel 254, the relevant values are of the order of 89 and 91 dB, respectively. Acoustic emissions for the ‘non-erosive’ test rig configurations are of the order of 84 dB for grade DH36 steel, 86 dB for cupronickel 70-30 and 90 dB for stainless steel, thus it appears that the difference between a ‘non-erosive’ and ‘erosive’ configuration would be 1 dB for the steel alloys and 3 dB for cupronickel in this instance. The variation between steel alloys and cupronickel as well as the dissimilarities with regards to the absolute values of the resulting acoustic emissions could possibly be attributed to the different properties and internal structure of the examined materials, resulting into a different sort of response against ultrasonically induced cavitation erosion. Nevertheless, one could interpret the results in terms of acoustic erosion ‘thresholds’ relating to ultrasonically induced cavitation as well as the examined alloys, mainly because the transition point between ‘non-erosive’ and ‘erosive’ cavitation was clearly identifiable, in all instances.

Acoustic emission measurements demonstrated that they can potentially be used as means of monitoring against ultrasonically induced cavitation erosion. The transition point between 'non-erosive' and 'erosive' cavitation was clearly identifiable in all cases, as differences ranging from 1 to 3 dB were measured, in relation to those conditions, for all examined alloys. The absolute values of the resulting acoustic emissions as well as the observed differences between different cavitation conditions appear to be related to the individual properties of each material in addition to cavitation intensity. As for fibre Bragg gratings, they demonstrated that they are at least capable of detecting cavitation, although more research would be required if one would wish to speak in terms of cavitation erosion intensity by means of those sensors.

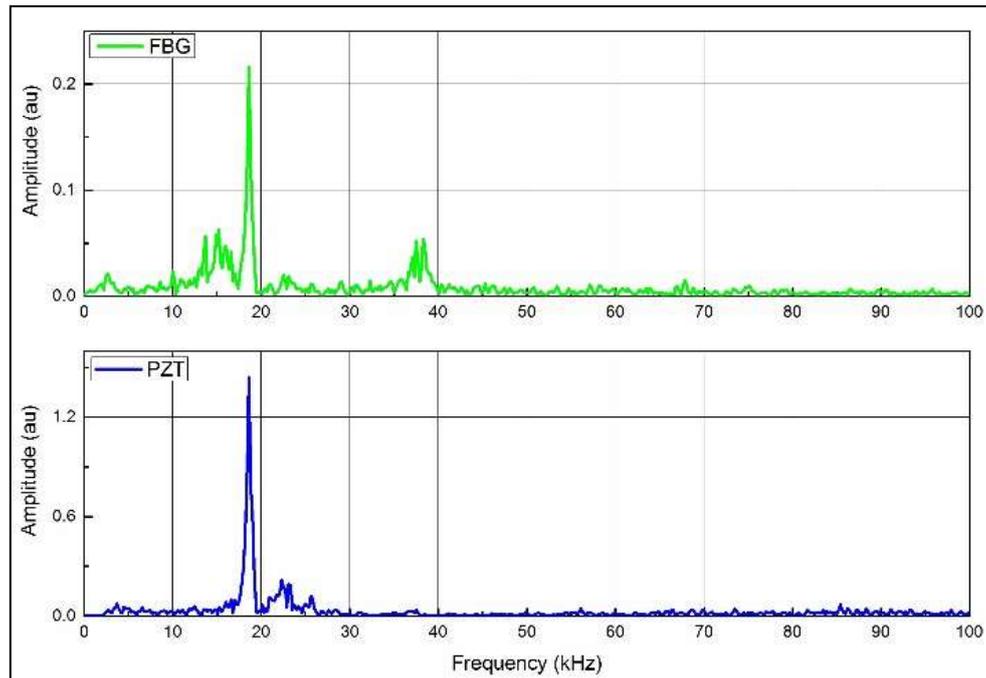
Figure 7. Frequency Response of Piezoelectric and FBG Elements through the 0-100 kHz Range

Finally, with regards to the frequency response which is presented in Figure 7 it can be clearly seen that there is a 19.5 kHz resonance which dominates the spectra, in conjunction with a few harmonics, and matches the operating frequency of the ultrasonic transducer. The detected resonance, however, originated from the exposed material itself, thus it is directly related to its internal response against the ultrasonically induced cavitation erosion. It is noteworthy that both types of acoustic sensors, namely piezoelectric and fibre Bragg gratings, were capable of clearly detecting that signal. Although this was in a way expected with regards to

the piezoelectric elements, in the case of fibre Bragg gratings it shows that they can be potentially be used for acoustic emission monitoring purposes.

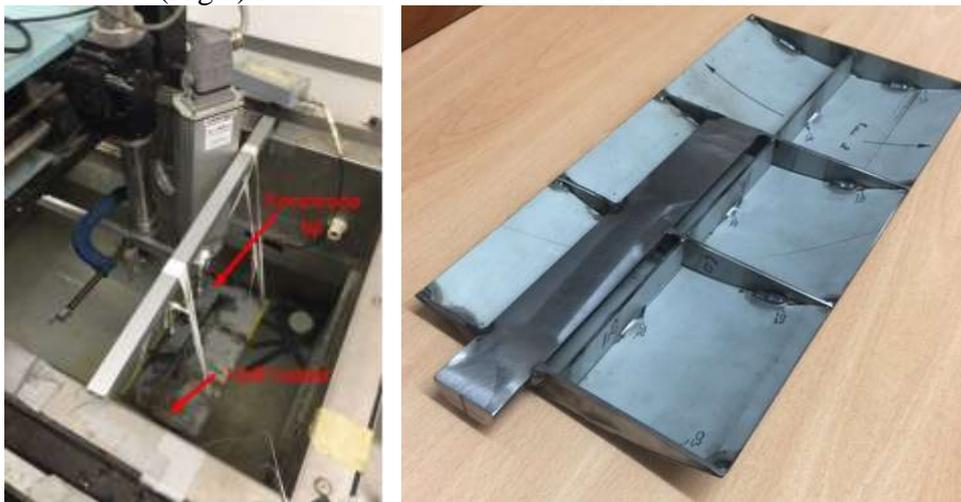
Following the successful application of acoustic emissions as means of erosion monitoring for ultrasonically induced cavitation, it was decided that the parameter of erosion localization should also be explored. Towards that direction a reduced-scale model of a ship rudder was designed and built by grade DH36 steel. The reduced-scale rudder model was then exposed to ultrasonically induced cavitation, by following a similar to the other measurements procedure, although in this case other parameters had to be taken into account as well. For instance, the size of the model rudder commanded that a larger tank should be utilized whereas the nature of the acoustic measurements would demand acoustic insulation of the examined object. As such tests were conducted in a large tank whereas the reduced-scale rudder model was positioned into that tank by means of two elastic cables. The test rig configuration as well as the reduced-scale rudder model can be seen in Figure 8.

Figure 8. (Left) *The Reduced-Scale Model Rudder Positioned inside the Large Water Tank* (Right) *The Reduced-Scale Rudder Model*

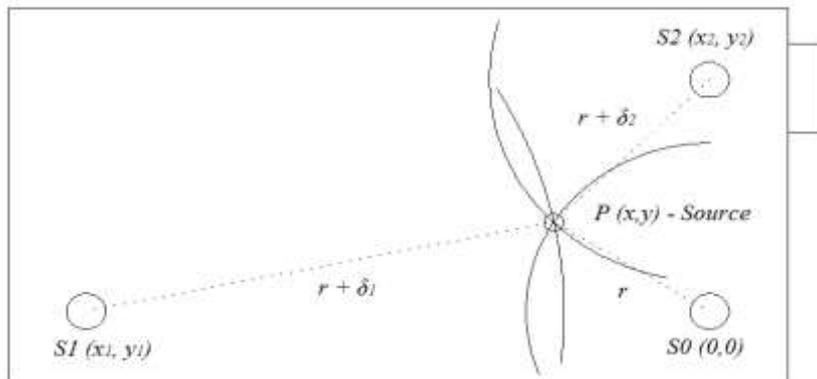
Cavitation erosion localization was conducted by means of a technique based on the principle of triangulation as this was described by Tobias (1976). The basis of this technique lies on an array of three acoustic sensors, located at points S_0 (0,0), S_1 (x_1, y_1) and S_2 (x_2, y_2) as well as the acoustic emission source to be located lying at the unknown point P (x,y) at a distance r from sensor S_0 . An acoustic emission event would then lead to a set of time differences δ_1 and δ_2 :

Under those remarks the acoustic emission source $P(x,y)$ would be located at the intersection of three circles with a radius of $r, r + \delta_1$ and $r + \delta_2$ whereas the centre of those circles would be located at points $S_0(0,0), S_1(x_1, y_1)$ and $S_2(x_2, y_2)$, respectively. An illustration showing the application of this technique on the surface of the reduced-scale rudder model can be seen in Figure 9.

Figure 9. The Application of the Triangulation Technique on the Surface of the Reduced Scale Rudder Model

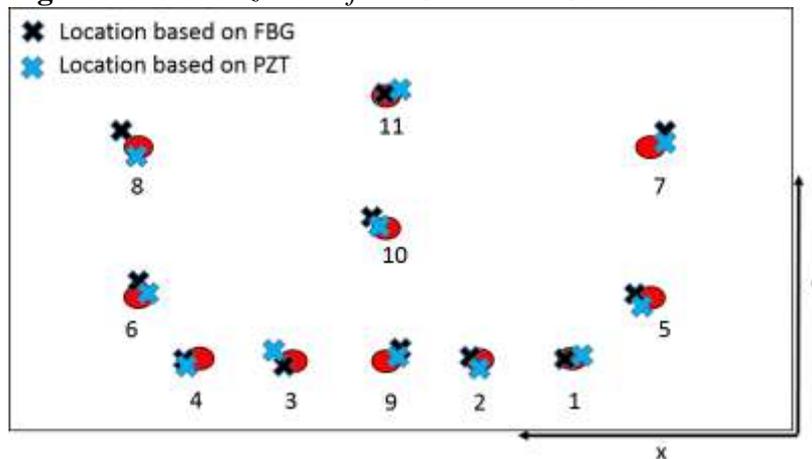
A total of four (4) acoustic sensors, piezoelectric and FBG, were used in these series of tests, as it was stated that the presence of a fourth sensor can greatly increase the accuracy of the triangulation technique. Moreover, eleven (11) different sonotrode placements dispersed all over the upper surface of the reduced-scale rudder were examined. The analytical solution of the sets of equations describing the aforementioned circles leads to the derivation of the coordinates of the intersection point – acoustic source for the eleven (11) different sonotrode placements. Results, for both the piezoelectric and fibre Bragg grating sensors, can be seen in a visualized form through Figure 10.

Figure 10. Visualization of the Calculated Sonotrode Placements

Red dots represent the coordinates of the actual location of the sonotrode.

In all cases, piezoelectric and fibre Bragg grating acoustic sensors proved to be capable of locating the source of erosive cavitation on the surface of the reduced-scale rudder model. Variations between the sensors and the actual coordinates of the sonotrode are possibly related to minor reflections of the resulting acoustic waves due to the presence of the shaft as well as the stringers inside the rudder. Furthermore, the required post-signal filtering could have also slightly influenced the accuracy of the calculations.

Finally, localization of ultrasonically induced cavitation erosion on the surface of a reduced-scale model rudder, by means of triangulation, proved to be effective. Both types of acoustic sensors, namely piezoelectric and fibre Bragg gratings, successfully detected the source of cavitation, whereas small discrepancies are believed to be mostly related to the internal structure of the rudder and the required signal filtering.
