A “Tearing Down” and the Aspiration to Something Greater: A Freedom Colony Church Falls in Vox Populi, Texas”

*By Michael O’Brien**

What caused the failure of the last vital cultural, educational, and spiritual institution in Vox Populi Texas, a freedom colony in Colorado County, Texas? Why were established balloon framing construction methods consistently compromised during the construction phases? Was this an example of faith over function? The wall failure which ultimately led to the abandonment of the South Point Baptist Church was investigated as part of a study of construction phasing and related compromises to the structural capacity of the structure in the context of balloon framing practices of the time from 1850 to 1920. This investigation was made possible by third-party theft/harvesting of interior sheathing and flooring which has exposed the improvisational wall and floor framing. Archival research on Vox Populi and the South Point Baptist Church was conducted at the Nesbitt Memorial Library, Columbus Texas. Digital models of the church construction phases were developed, and framing detail models constructed of key structural conditions to understand their modificat

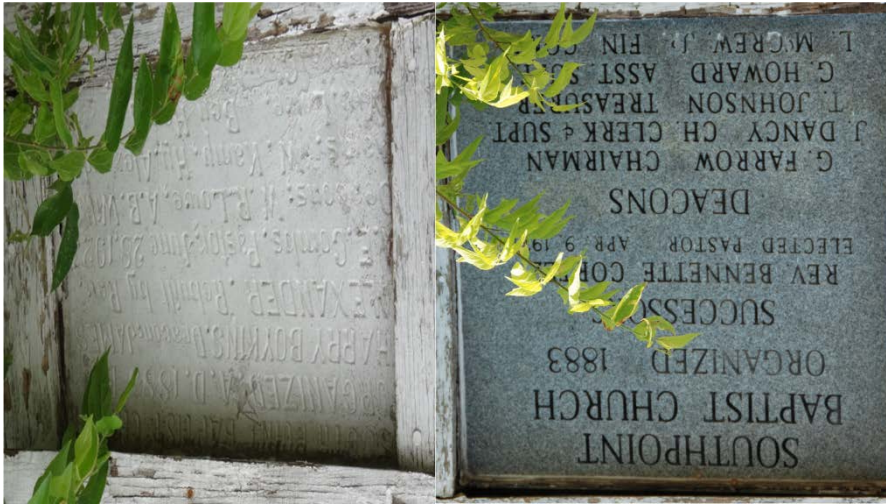
Figure 1. Cornerstones 1971 (Left) 1923 (Right)

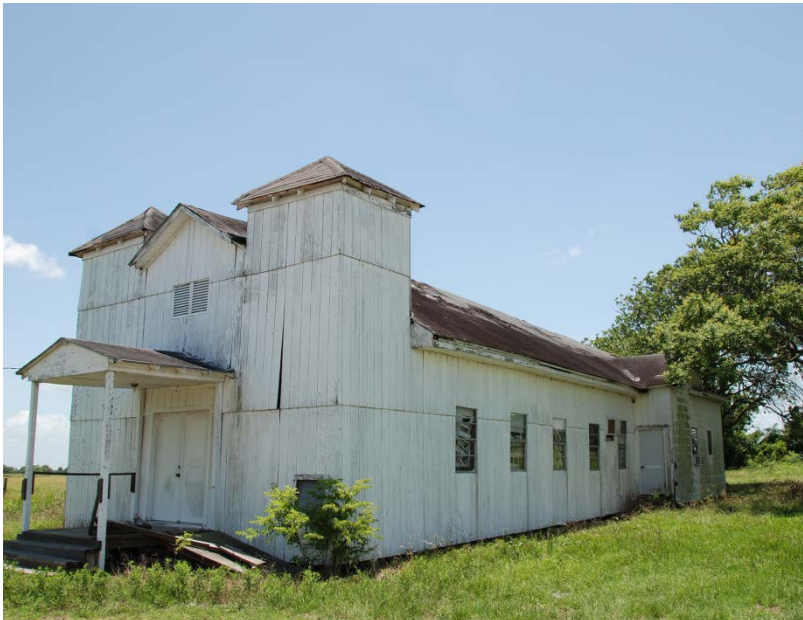
Figure 2. South Point Baptist Church, View from North 2014

church, which based on trophies visible in 2014, was still a vibrant congregation up through 2007. The sill/wall connection along the western wall shows evidence of extensive water and insect damage, perhaps leading to the rotting of the corner post base and sill connection, thus "freeing" the southern sill beam to move and the attached southern wall to lean precariously.

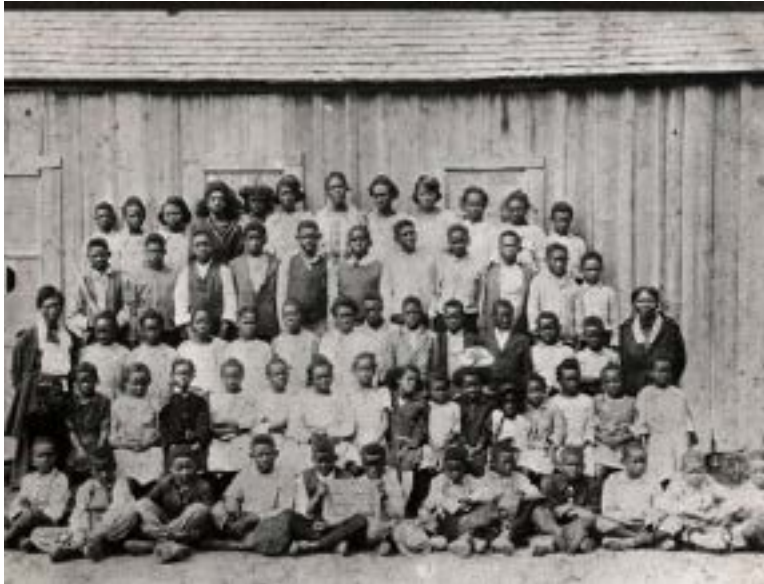
Figure 3. *Vox Populi School*

Figure 3 of the Vox Populi school class shows the “single wall” or “box and strip” form of construction which helps establish the towns’ ability to produce

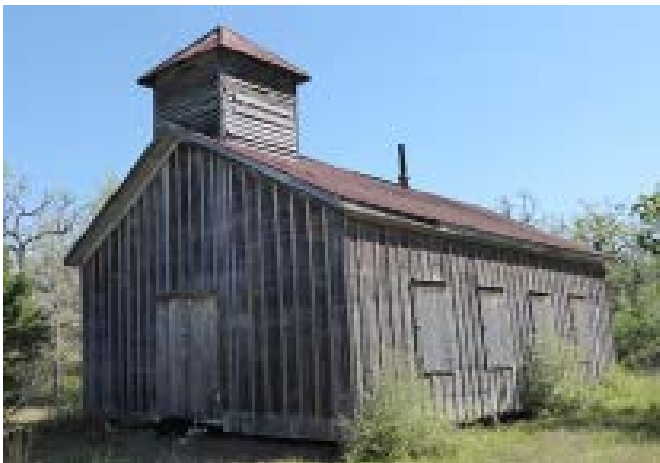
Figure 5. Pleasant Hill Baptist Church Colorado County Tx. ca. 1880
Source: Michael O'Brien Image.

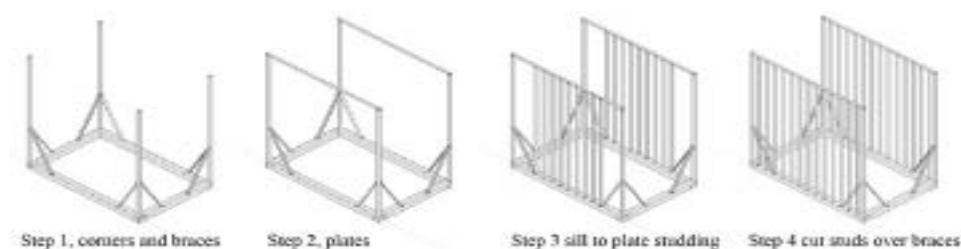
The evidence for these towers and narthex being a later addition includes: the corner braces in existence in the phase I corner on the west side of the towers. One would wonder why would a carpenter put a “corner brace” effectively seven feet away from the tower corner? My response would be that the presence of the braced meeting hall, but unbraced tower confirms that the carpenter placed the brace in this location because the phase two addition was not yet conceived, and the brace was required to anchor the corner post as traditional balloon framing practice would have it.

Figure 15. *Balloon Frame Process Dependent on Down Braces to Stabilize Corners*
 Source: From “Hybrids on the Way to Western Platform Framing”²⁵.
