A Villa and a Hiding Underground Compound from the Late Second Temple Period in the Judean Lowlands

Introduction

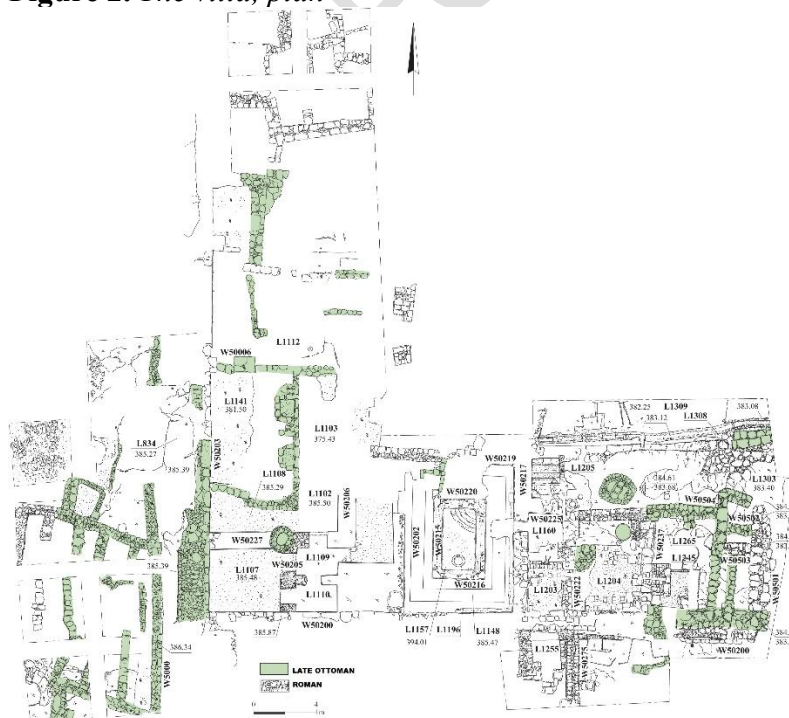
Figure 2. *The villa, plan*

In Area D, located on the hilltop, a villa measuring 35×43 m was uncovered and dated to the late Second Temple period (late 1st century BCE to early 2nd century CE; Fig. 2). The villa's location provided extensive views over the surrounding region and control over the roads leading to the hill from the directions of Beit Guvrin and Jerusalem.

The villa consisted of four wings:

- a **central wing**, containing a rectangular courtyard with a pool at its center;
- a **western wing**, used for residential purposes;
- an **eastern wing**, containing a bathhouse;
- a **northern wing**, poorly preserved, which likely served as the entrance to the structure.

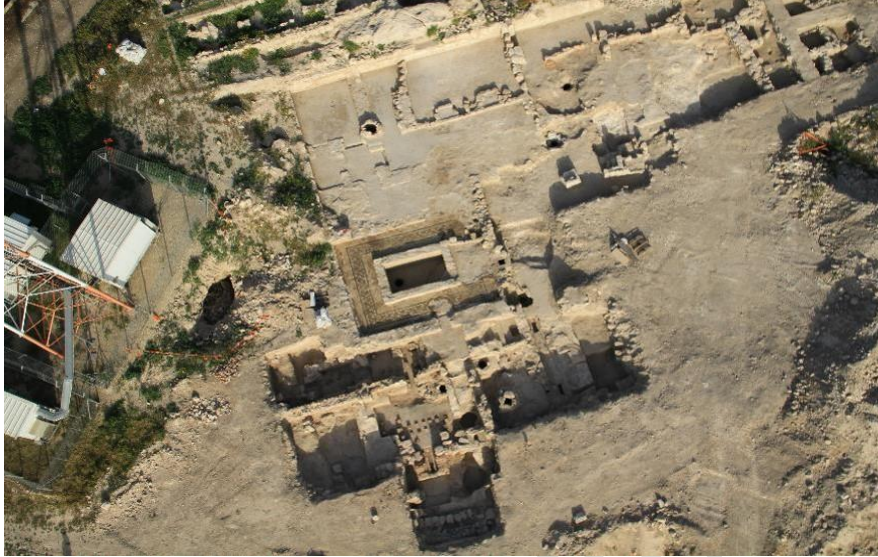
Figure 3. *The villa, aerial photo*

The central wing formed the architectural and functional core of the villa and 35
was dominated by a carefully planned rectangular courtyard measuring $6.2 \times$ 36
 8.6 m, aligned along a north–south axis (Fig. 3). This orientation, typical of 37
well-designed Roman-period residences, may have been intended to optimize 38
light, airflow, and spatial organization. The courtyard was enclosed on all four 39
sides by walls (W50200, W50202, W50217, W50219), constructed of medium- 40
sized, well-dressed chalk stones. These stones were carefully arranged and 41
finished, reflecting a relatively high standard of construction. The inner faces 42
of the walls were coated with light gray plaster, likely both for aesthetic 43
and functional purposes. 44
of the walls were coated with light gray plaster, likely both for aesthetic 45
and functional purposes. 46

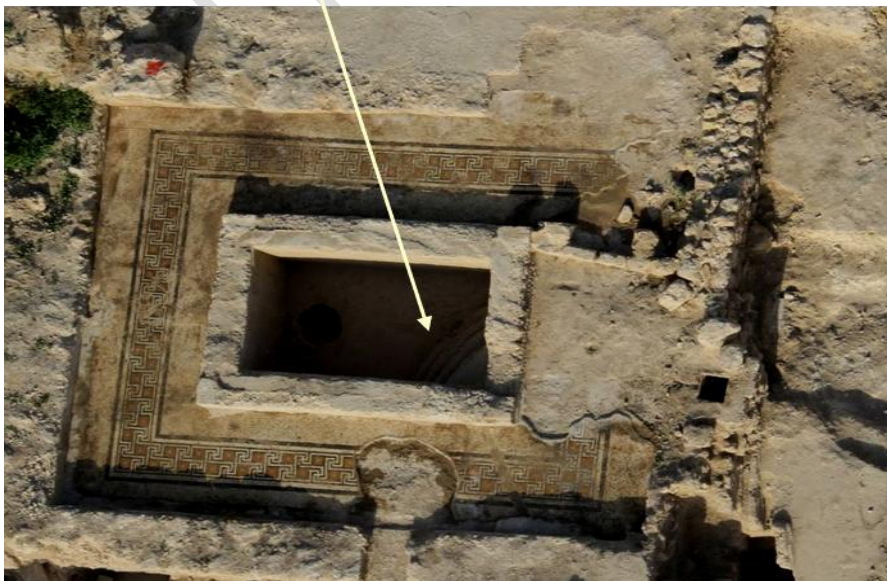
Figure 4. *The pool at the central courtyard*

At the heart of the courtyard lay a rectangular pool (L1157; 2.0×3.9 m; approximately 1.5 m deep; Fig. 4), which served as both a functional and decorative element. The pool was enclosed by four solid walls, each approximately 0.5 m thick, which were fully preserved and coated with high-quality white plaster to ensure water retention and a clean appearance. The pool's design reflects a combination of utility and display, characteristic of elite rural residences.

Evidence for the architectural embellishment of the pool comes from imprints preserved at the tops of the surrounding walls, indicating the former presence of six column bases (each about 0.45 m in diameter). These columns likely supported a light superstructure, perhaps a pergola or partial roof—and were arranged symmetrically: four at the corners of the pool and two centered along its longer sides. This arrangement would have created a visually striking focal point within the courtyard, possibly providing shade and enhancing the aesthetic quality of the space.

Access to the pool was provided by four semicircular steps set into its northeastern corner, descending to the plastered floor. The curved design of the steps suggests careful planning and attention to comfort and visual harmony. Near the southern wall of the pool, a repair (L1196) was identified in the floor, indicating maintenance activity during the period of use. Beneath this repair, the opening of an earlier installation—a cistern measuring 1.9×3.8 m—was revealed. This earlier cistern had been intentionally decommissioned and incorporated into the later construction of the pool, illustrating a sequence of architectural modifications.

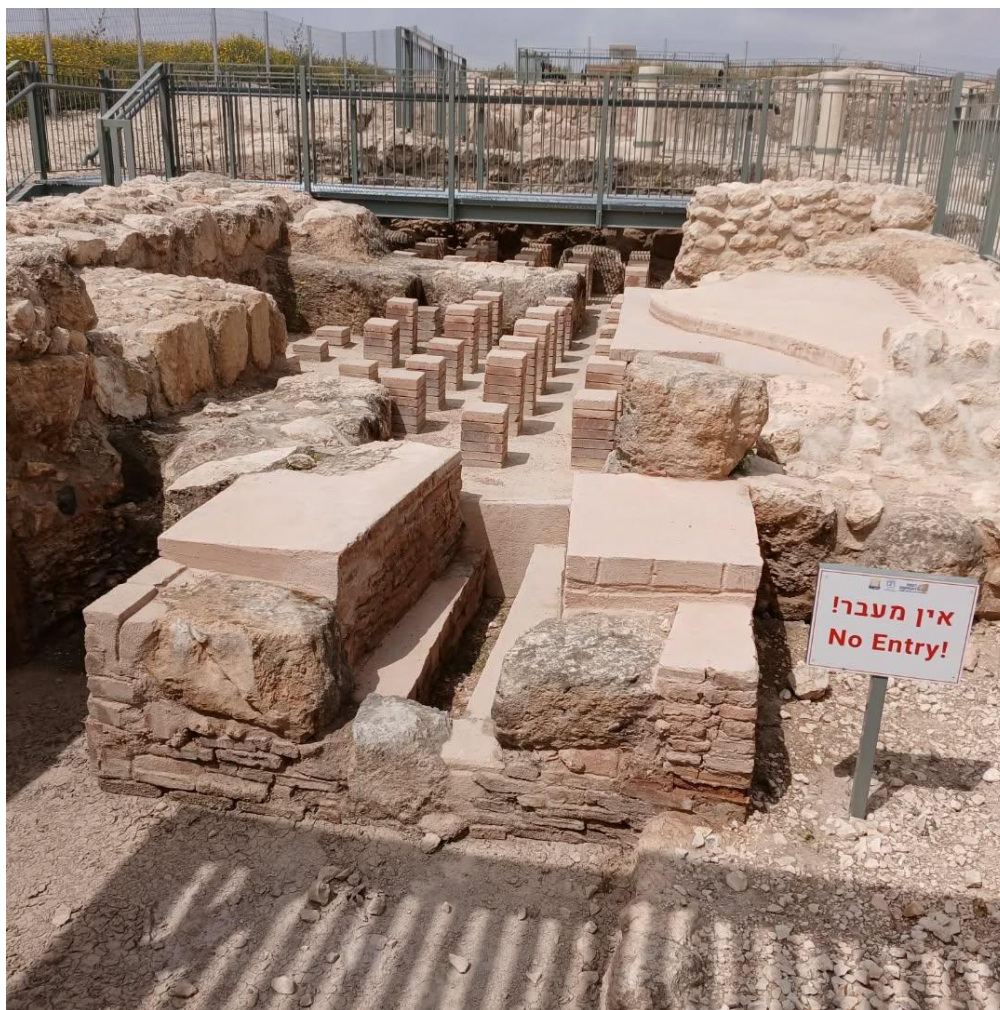
The eastern wing housed a bathhouse complex, incorporating all the essential elements of a Roman bathing facility and reflecting a high level of technological sophistication. The presence of such a bathhouse is a strong indicator of the villa's elite status and the adoption of Roman cultural practices (Fig. 5). 29
30
31
32
33
34

The bathhouse after restoration works.

Access to the bathhouse was provided from the central courtyard through a doorway leading into an antechamber (Room 7; 2.0 × 2.5 m). This space likely served as a transitional area where bathers prepared before entering the heated rooms. It may originally have been paved with a fine mosaic floor, although no clear remains of such decoration were preserved.

To the north of the antechamber was a small, plastered pool (Room 8; 1.8 × 2.5 m), accessed by four steps descending into it. This pool may have functioned as a cold bath (*frigidarium*) or as part of the bathing sequence.

South of the antechamber lay the hot room (*caldarium*; Room 9; 2.5 × 3.2 m), which is among the best-preserved elements of the villa. Its floor consisted of square ceramic tiles supported by a hypocaust system—an underfloor heating installation typical of Roman baths. The hypocaust space contained numerous fragments of fired bricks and ceramic pipes, as well as some bricks preserved in their original positions, providing valuable evidence for the construction and operation of the heating system.
