## Ultrasound Applications in the Safety Assessment of Concrete Structures

By Roberto C. A. Pinto\*, Isaque V. Tinoco<sup>±</sup>, Pedro P. M. Martins<sup>°</sup> & Jhulis M. Carelli<sup>•</sup>

*The safety assessment of concrete structures involves regular inspections to evaluate the real condition of the structure. A concrete structure is subjected to cracking whenever the developed tensile stresses due to deterioration processes or structural loads surpass the tensile strength of the material. While some cracks may only affect aesthetics, others may impair the durability and serviceability of the concrete structure. When monitoring cracking, nondestructive techniques (NDT) are commonly used. The use of stress wave propagation methods such as ultrasound allows one to indirectly evaluate the cracking process in a convenient and fast approach. This paper discusses the application of ultrasound to assess the integrity of concrete structures subjected to cracking of different nature. In particular, plastic shrinkage cracking and the crack repair with epoxy were evaluated through ultrasound. Ultrasound energy parameters were able to indicate the extent of plastic shrinkage cracking

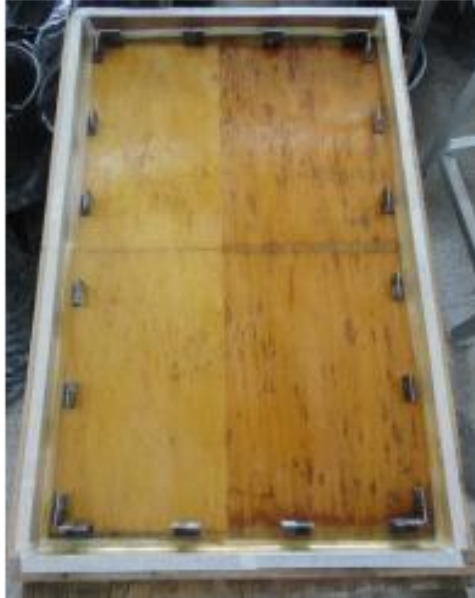
**Figure 2.** *Wooden Molds with Steel Angles*

In the confection of the wooden molds, while the bottom was sealed with varnish, the sides were covered with a polyethylene film. Thus, water could only evaporate from the slab surface. Steel angles of 35 x 20 x 20 mm of size and 2.65 mm thickness were used to restrain the slab edges, and thus preventing any substantial movement. All these measures were taken to facilitate cracking. These steel angles were fixed on the bottom of the molds in pairs spaced at around 130 mm along the perimeter, as can be seen in Figure 2.
